# **BRIDGE CONDITION REPORT**

<b>REGION:</b>	<b>1</b>
<b>DISTRICT:</b>	<b>1</b>
<b>ROUTE:</b>	<b>Fox River Trail North Island Bridge</b>
<b>OWNER:</b>	<b>Geneva Park District</b>
<b>COUNTY:</b>	<b>Kane</b>
<b>JOB NUMBER:</b>	<b>P-91-057-07</b>
<b>STRUCTURE NUMBER:</b>	<b>None</b>
<b>LOCATION:</b>	<b>Fox River Trail North Island Bridge (IL 38 at IL 25)</b>
<b>PREPARED BY:</b>	<b>Mark S. Wylie, Farnsworth Group, Inc.</b>
<b>DATE PREPARED:</b>	<b>October 17, 2007</b>
<b>PROPOSED LETTING DATE:</b>	<b>Unknown</b>

Structure Number:	None
County:	Kane
Route Carried:	Fox River Trail
Feature Crossed:	Backwater Channel of Fox River
Section:	06-P0005-00-BR
Station:	12+92.00
Roadway Classification:	Pedestrian/Bike Trail
Design/Posted Speed:	10 mph
ADT (current/design):	N/A
ADTT (current/design):	N/A
DHV:	N/A
Inventory Rating HS:	None
Operating Rating HS:	None
Sufficiency Rating:	None

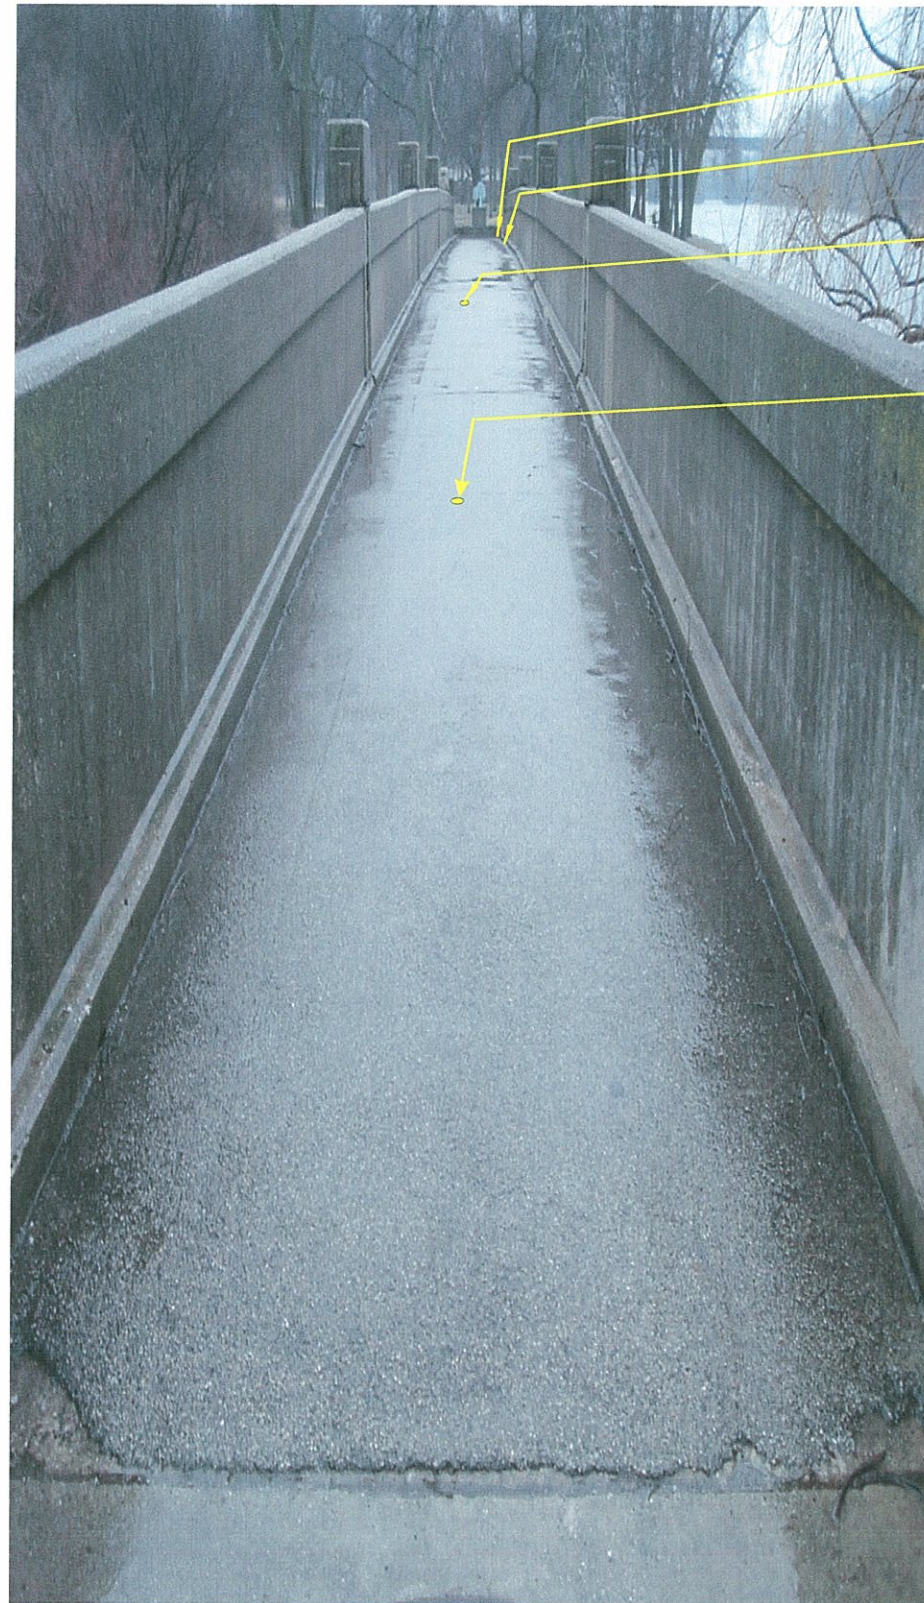
General view of the bridge and core locations

- Core location C-4
- Core location C-3
- Core location C-2
- Core location C-1

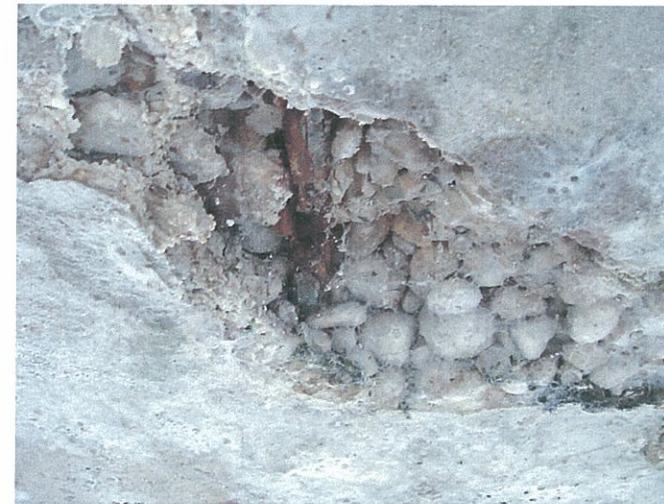
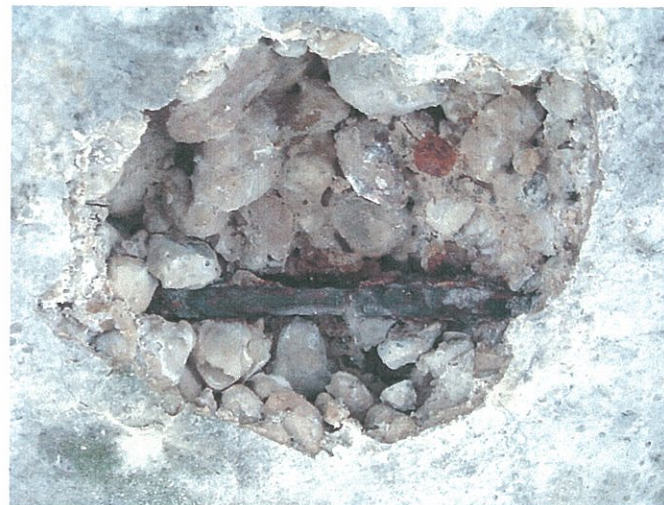
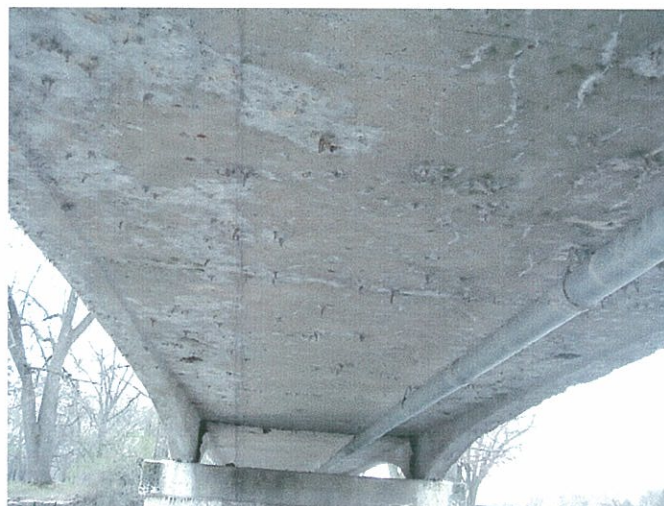
The slab itself manifests concrete delamination through its entire depth, particularly pronounced in the areas immediately below the interface zone with asphalt and in the lower portion. The latter can be attributed to poorly consolidated concrete exhibited by the slab underside (see photo 2 below and attached Figure 1) .

Photo 2 - Pockets of exposed aggregate particles with no cement paste bond were found in several areas of bridge underside.

Photos of bridge view from bottom showing examples of poor consolidation of concrete in the original construction and signs of efflorescence

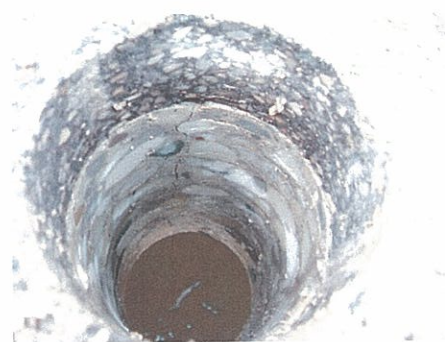
Photo of Core C-1 - top view

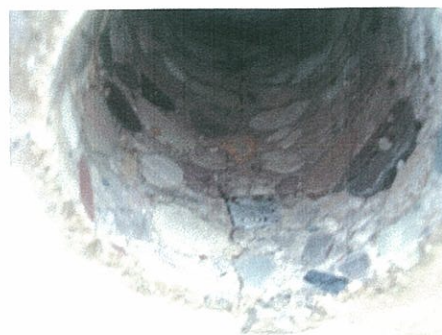
Photo of Core C-1 - view from bottom

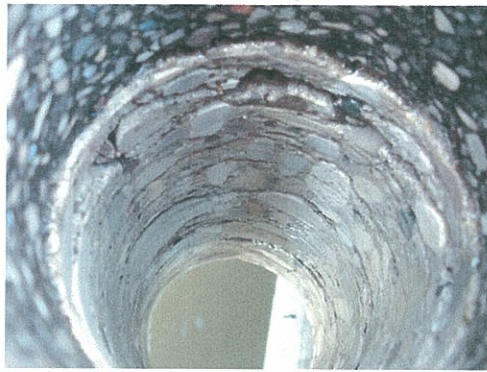
Photo of Core C-3 - top view

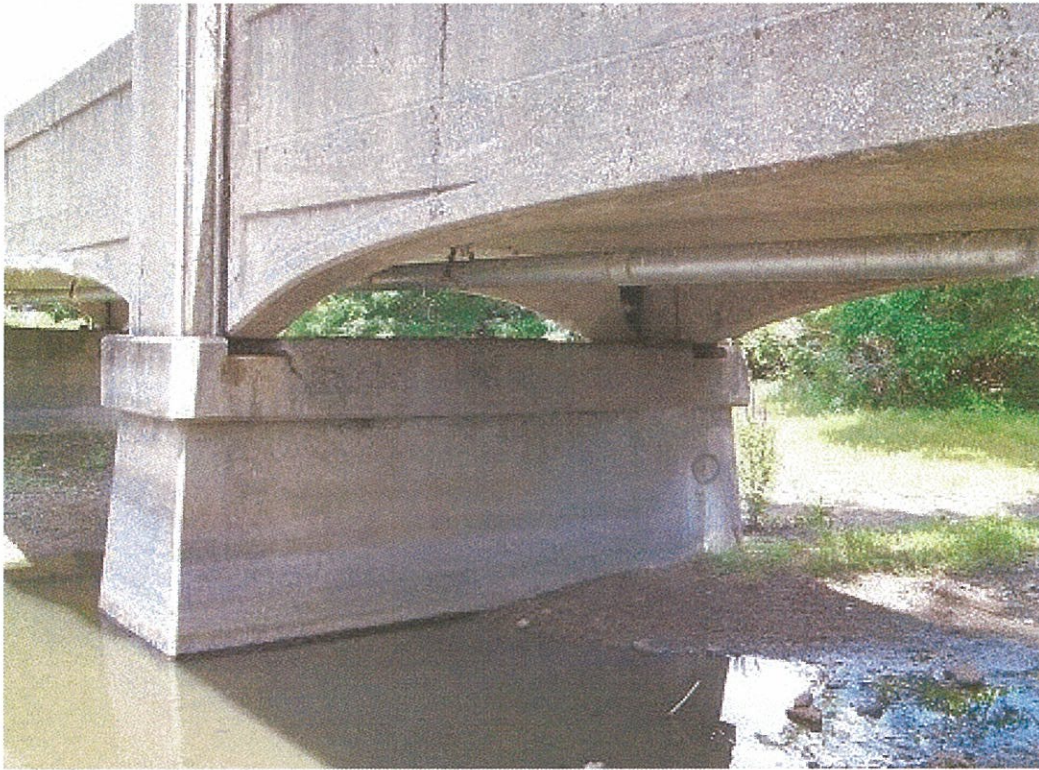
**Fig. 3 Pier 1 South Face Core 3 Upper Core**

Cores C3 and C4 represent the south and north face of Pier # 1. Core C3 revealed a diagonal crack that extends thru the cross section of the core. Also, several superficial hairline cracks were observed just below the top or surface of the core. Core C4 was found in sound condition with no evidence of deterioration.

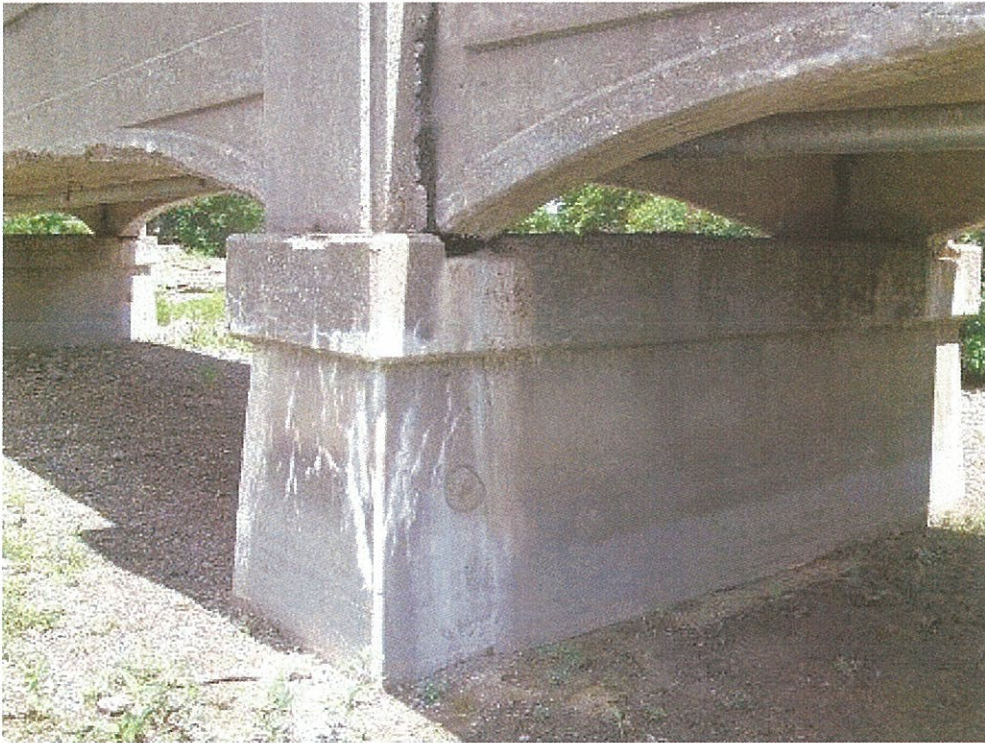
**Fig. 8 Pier 2 South Face Core 5 Upper Core**

Cores C5 and C6 represent the south and north face of Pier # 2. Core C5 is considered to be in sound condition and no evidence of deterioration. Core C6 revealed one crack that extended thru the cross-section of the core. The crack is located approximately seven inches below the top or surface of the core.

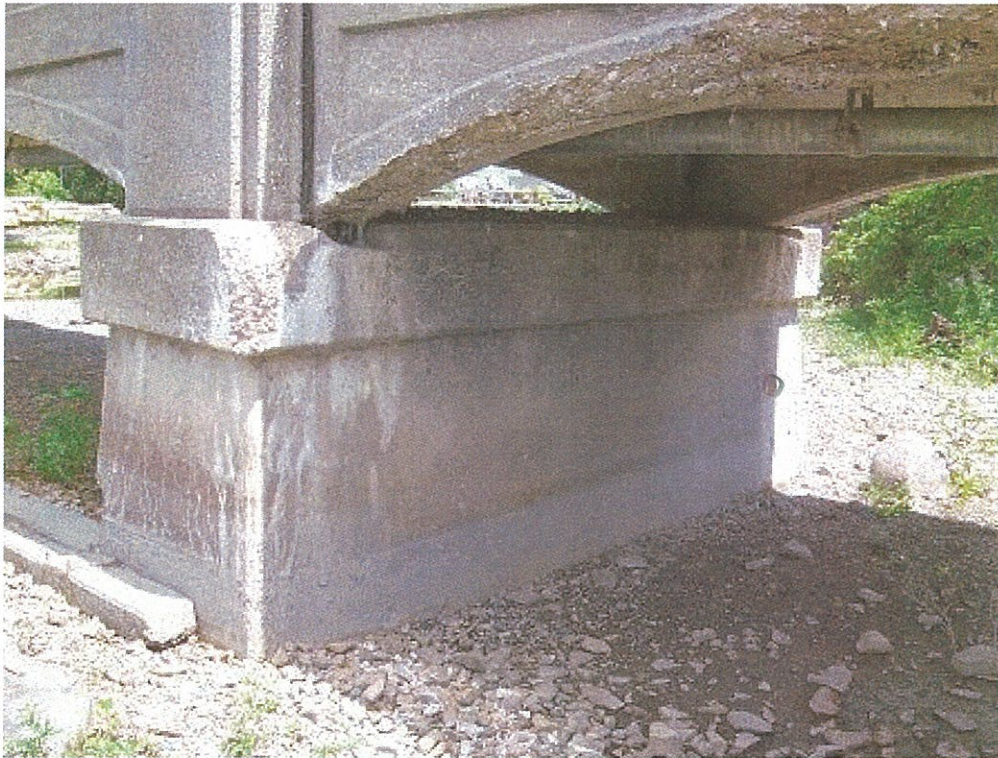
**Fig.10 Pier 3 South Face Core 7 Lower Core**

Cores C7 and C8 represent the south and north face of Pier # 3. Core C7 revealed one crack that extends thru the cross-section of the core. Several superficial hairline cracks were also observed just below the top or surface of the core. Core C8 revealed one diagonal crack that extends thru the cross-section of the core. The crack is located approximately four inches below the top or surface of the core.

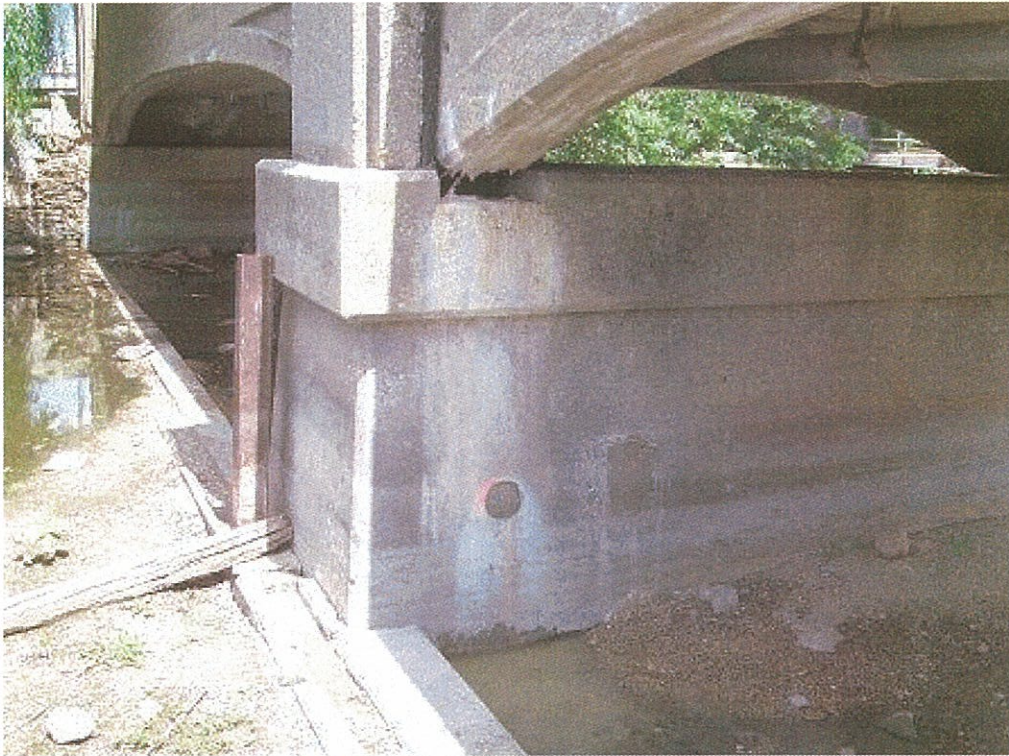
**Fig. 14 Pier 4 South Face Core 9 Lower Core**

Cores C9 and C10 represent the south and north face of Pier # 4. Each of the cores were observed to be in sound condition with no evidence of deterioration.

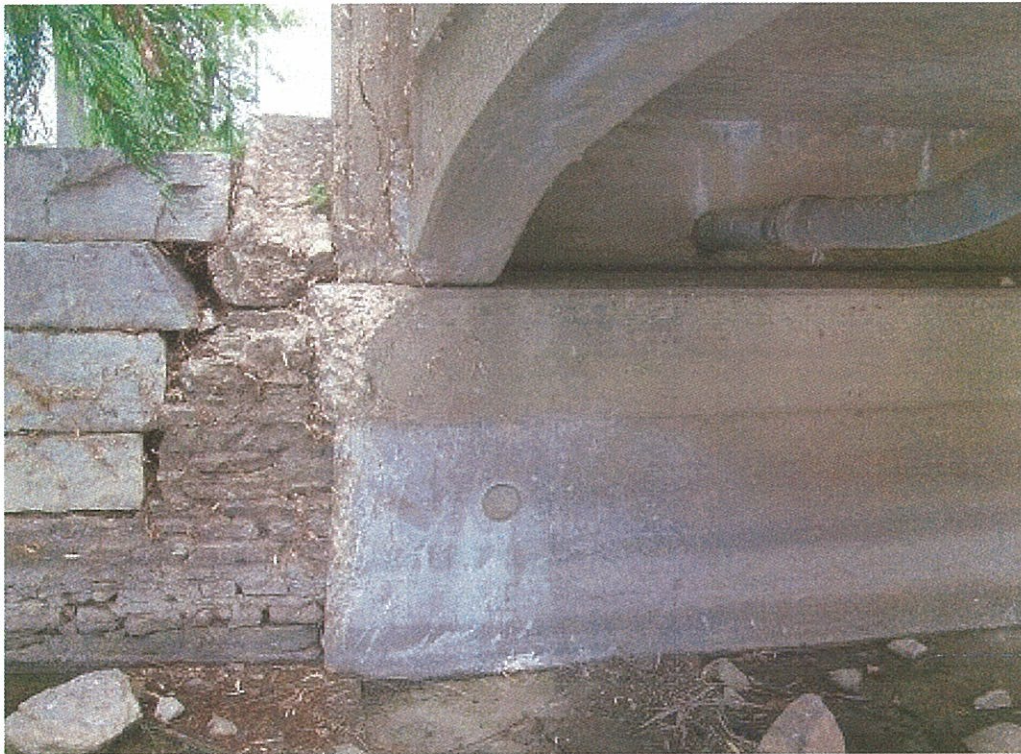
**Fig. 16 North Abutment Core 12 Upper Core**

Cores C11 and C12 represent the North Abutment Wall. Each of the cores revealed several cracks that extend thru the cross-section of the cores. Cracks were located approximately two to five inches below the surface of core C11 and two and five inches below the surface of core C12.

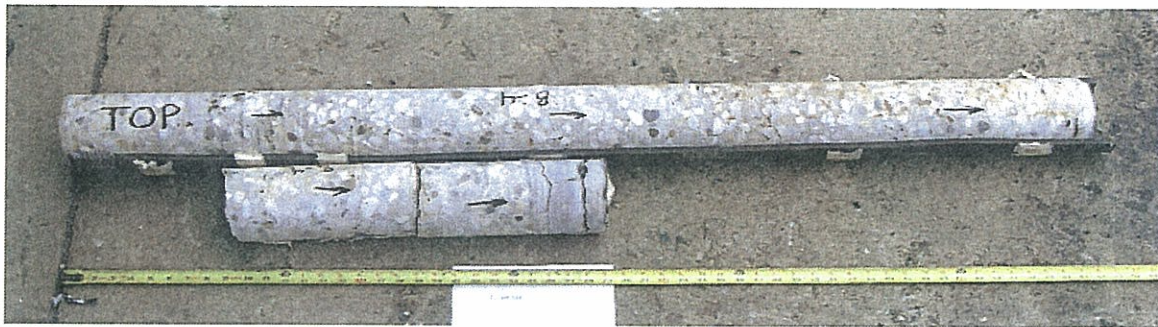
**L-69,344**  
**BORING 4**  
**PIER 3**  
**2.5'-8.5'**

BORING NUMBER	BRIDGE DECK	PIER OR ABUTMENT	SUPPORT MATERIAL
1	0"-1.5" Bituminous Concrete	2.5'-9.4' P.C. Concrete	9.4'-11' Dolomite
	1.5"-7" P.C. Concrete		
2	0"-2" Bituminous Concrete	2.5'-9.2' P.C. Concrete (Horizontal Crack at 3.4')	9.2'-9.5' Dolomite with clay partings
	2"-7.5" P.C. Concrete		
2A	0"-2" Bituminous Concrete	2.5'-10' P.C. Concrete (Horizontal Crack at 3.4')	9'-10' Fractured Dolomite and Gravel
	2"-7.5" P.C. Concrete		
3	0"-3" Bituminous Concrete	2.5'-9' P.C. Concrete	9'-11' Dolomite
	3"-9" P.C. Concrete		
4	0"-2¼" Bituminous Concrete	2.5'-8.5' P.C. Concrete	8.5'-9' Dolomite
	2¼"-2½" Steel Plate		
	2½"-9" P.C. Concrete		
5	0"-2" Bituminous Concrete	2.5'-8.3' P.C. Concrete	8.3'-10' Dolomite
	2"-8" P.C. Concrete		
6	0"-1" Bituminous Concrete	2.5'-8' P.C. Concrete (Horizontal Crack at 3.6')	8'-13.5' Dolomite
	1"-8" P.C. Concrete

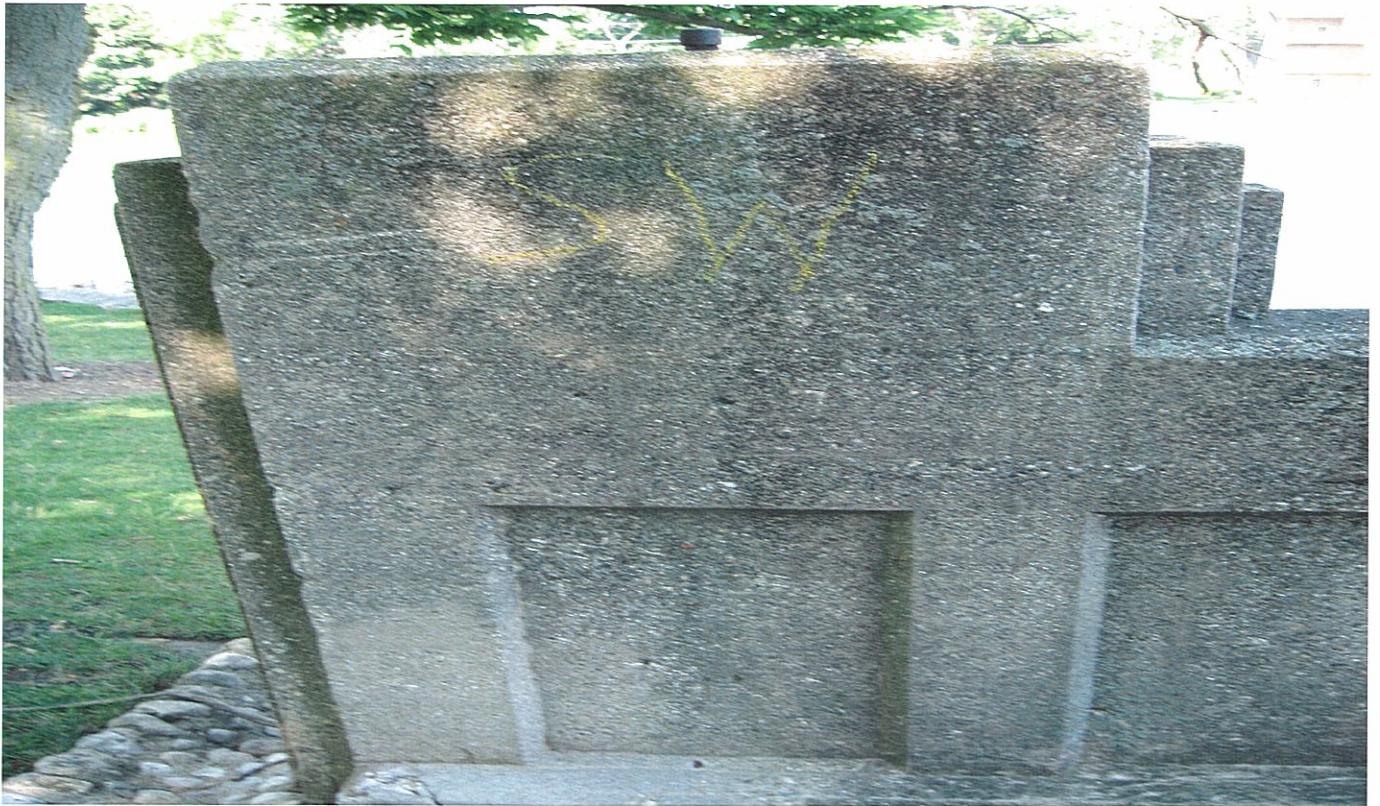
West Side South Pilaster at South Abutment (Typical Pilaster)

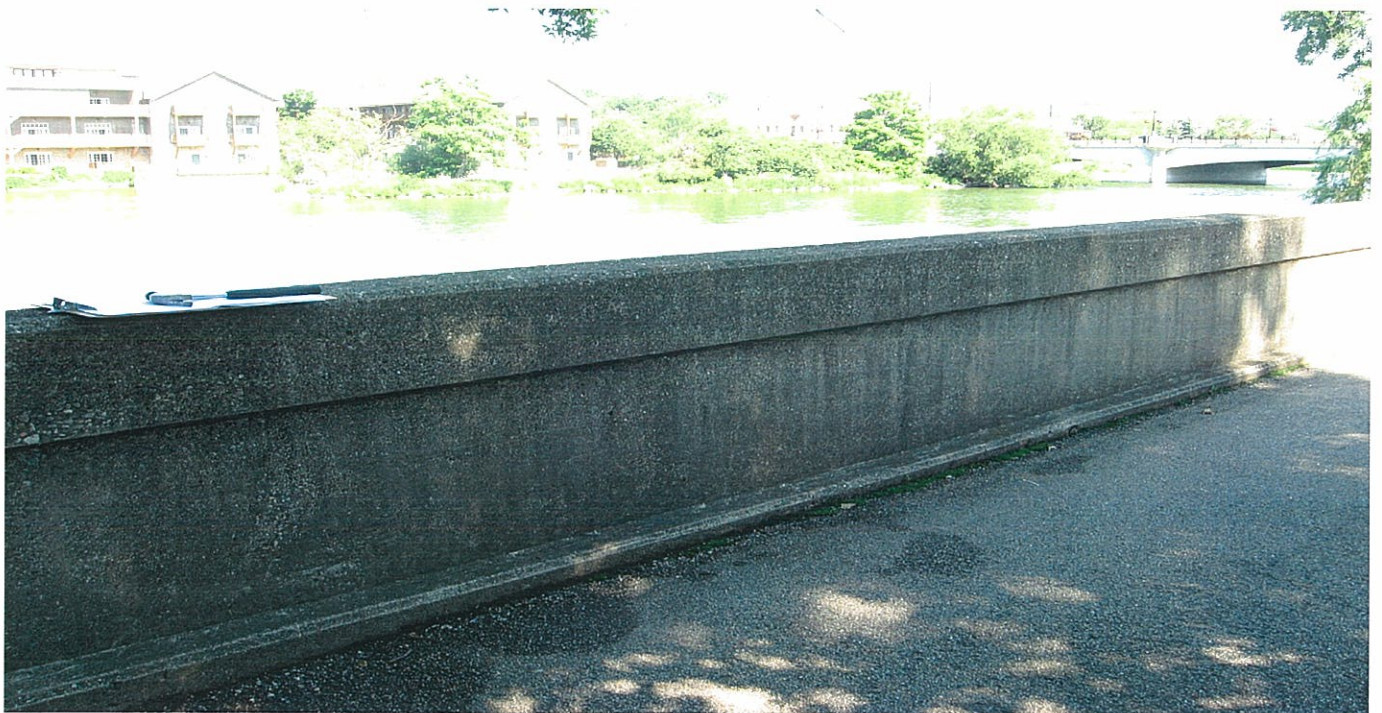
West Side Rail South Abutment to Pier 1 (Typical Rail West Side)

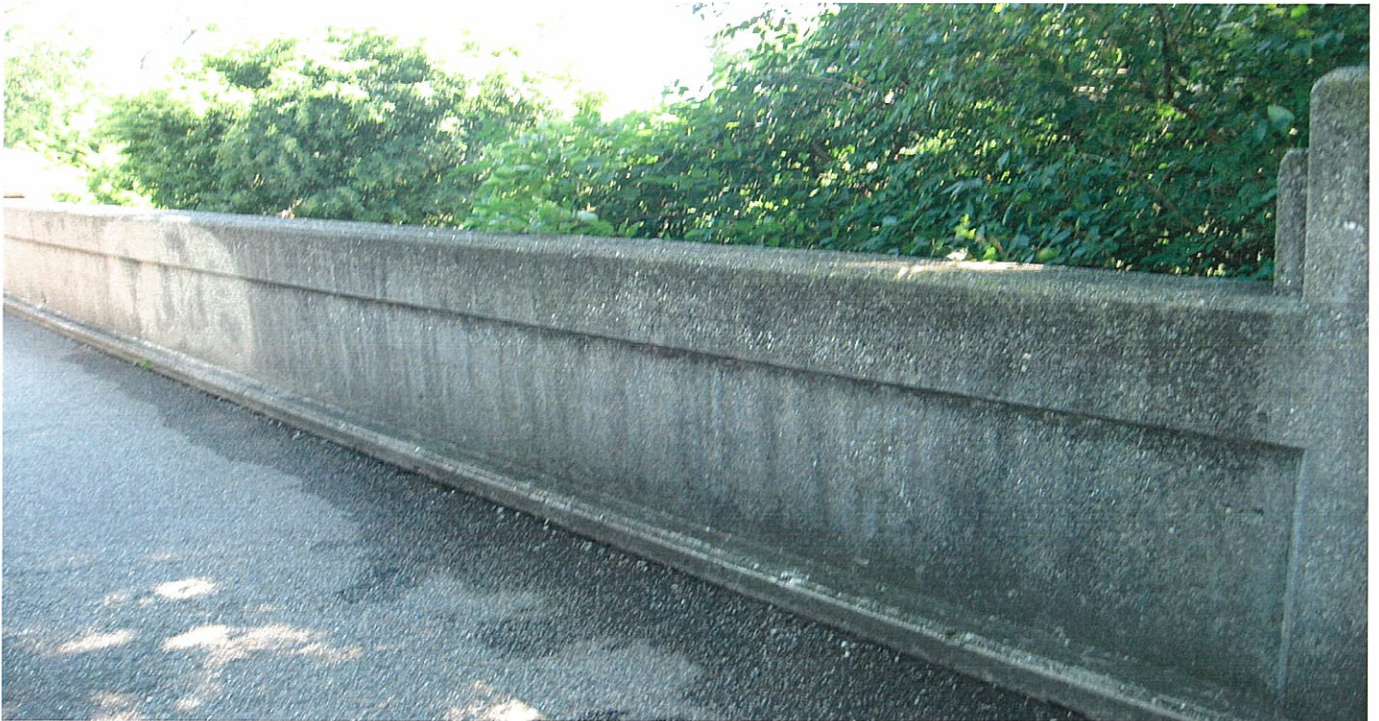
East Side Rail South Abutment to Pier 1 (Typical Rail East Side)

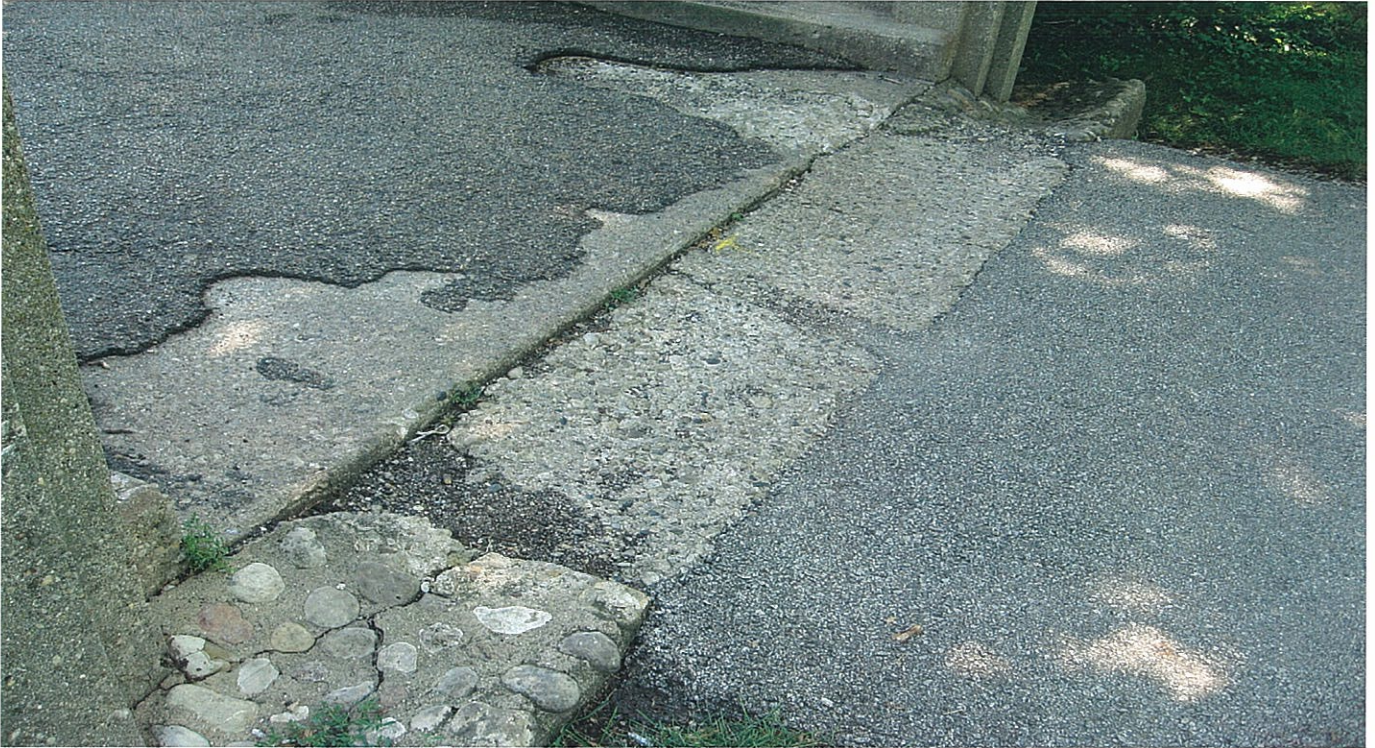
Joint/Gutter South Abutment

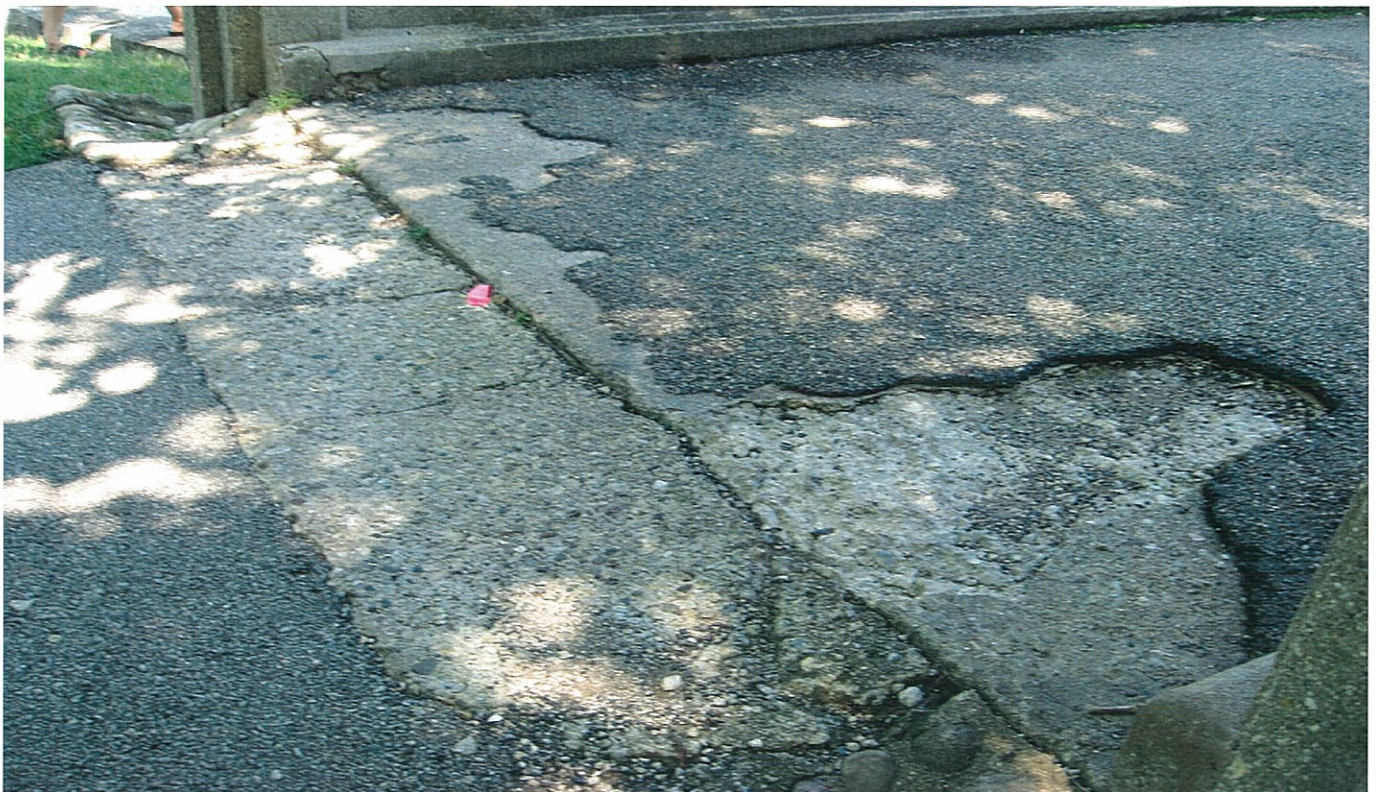
South Abutment Joint

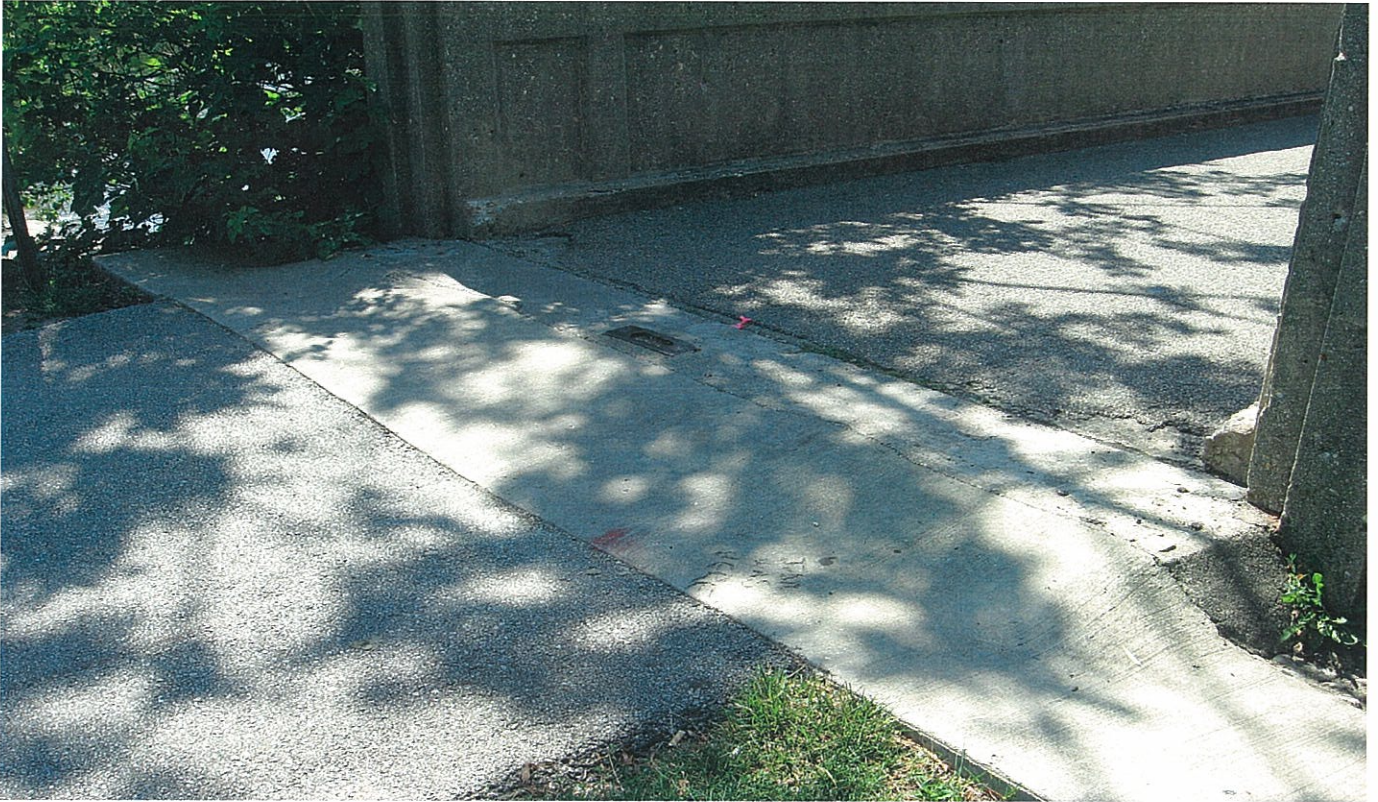
Joint/Gutter North Abutment

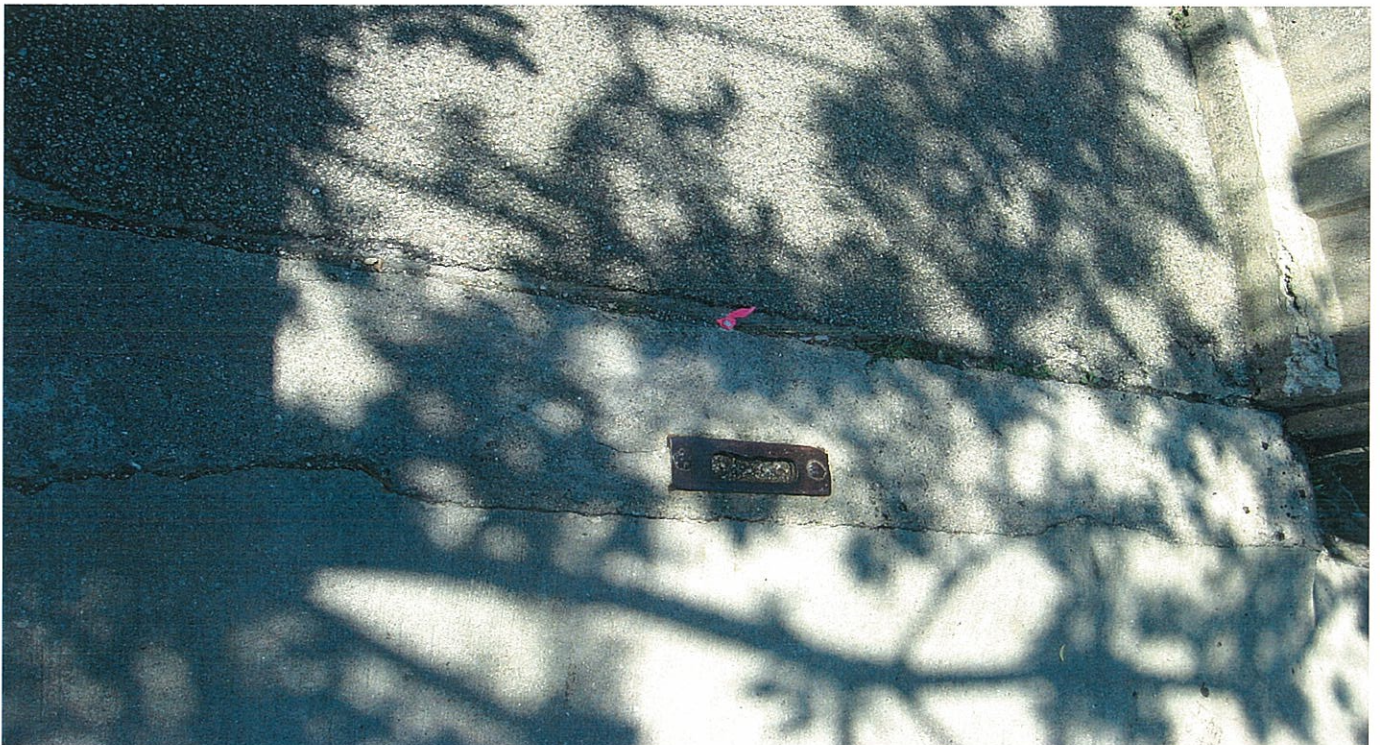
Joint at North Abutment

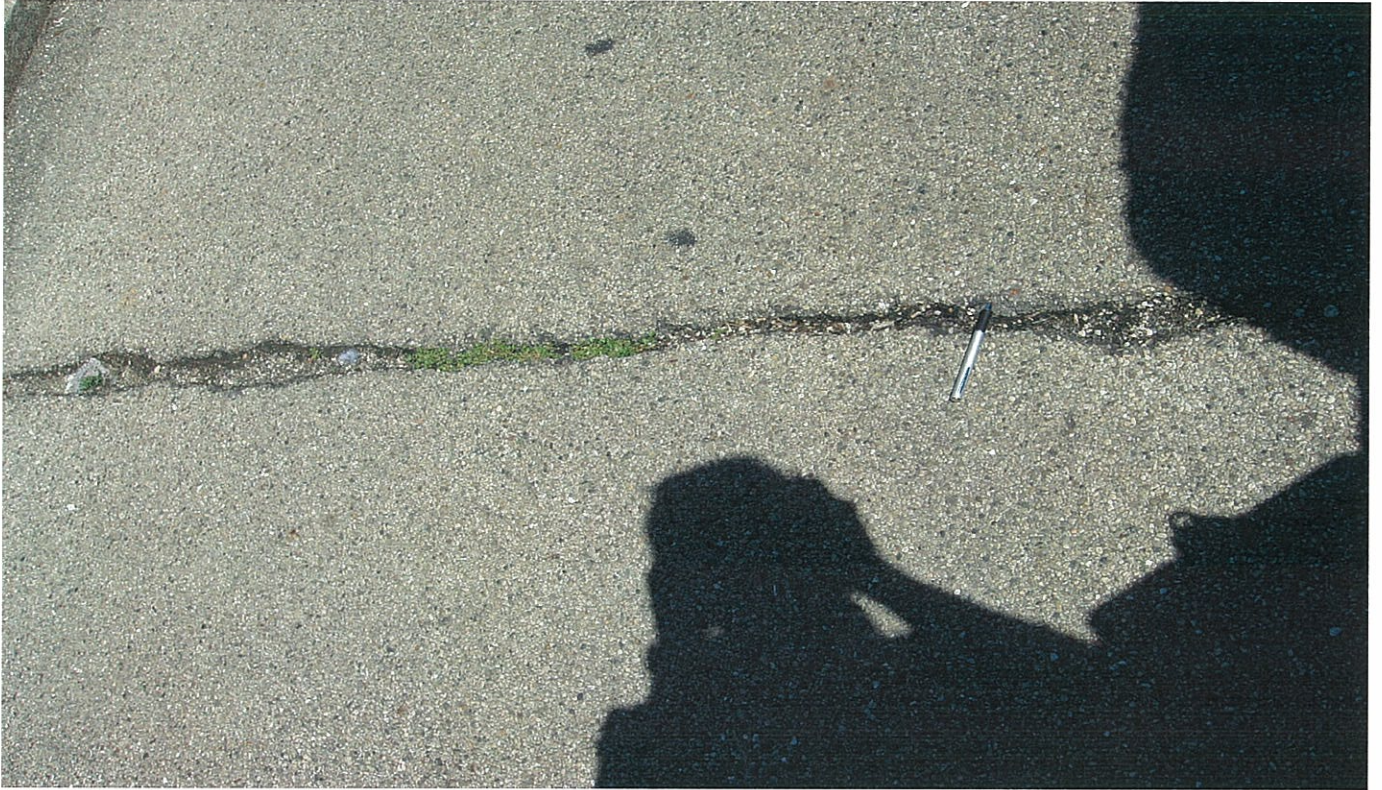
Pier 1 Joint

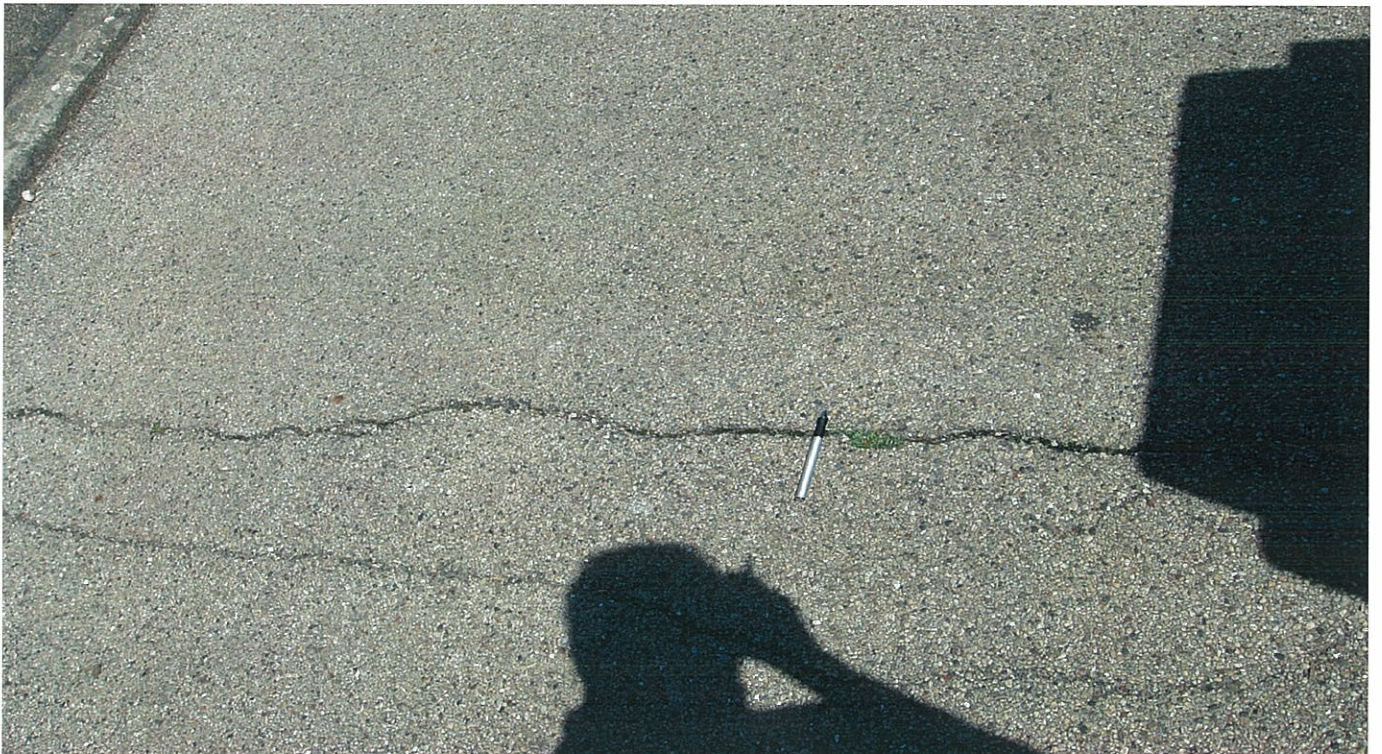
Pier 2 Joint

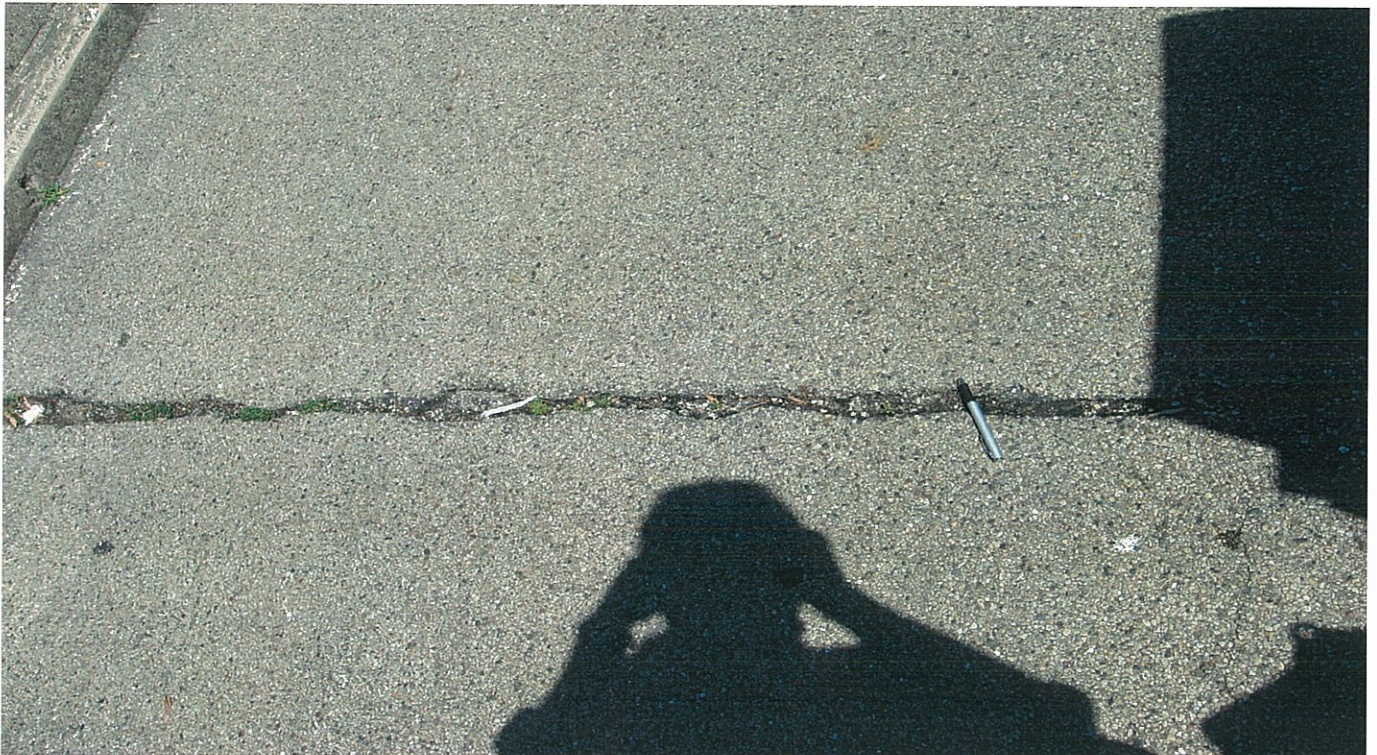
Joint at Pier 4

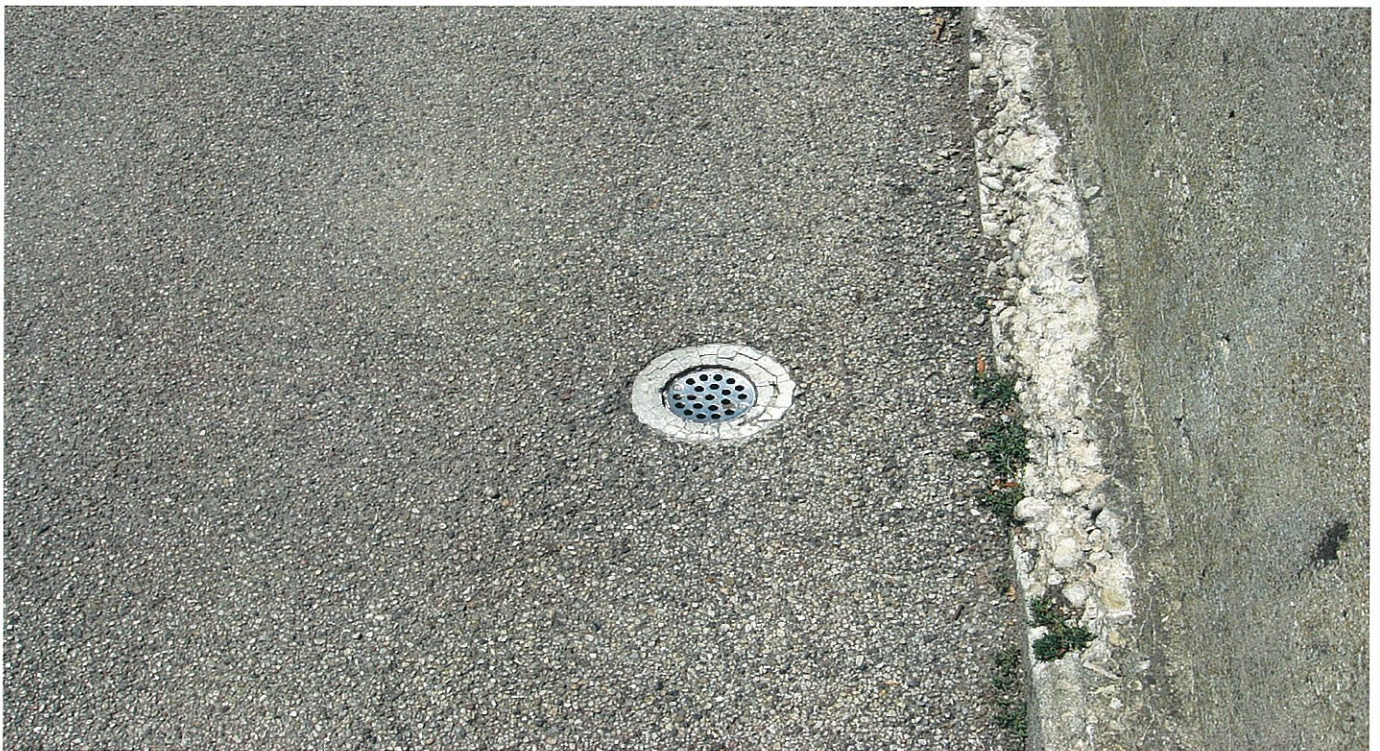
Typical Drain in Deck  $\pm 10'$  West of Pier 3 North Side

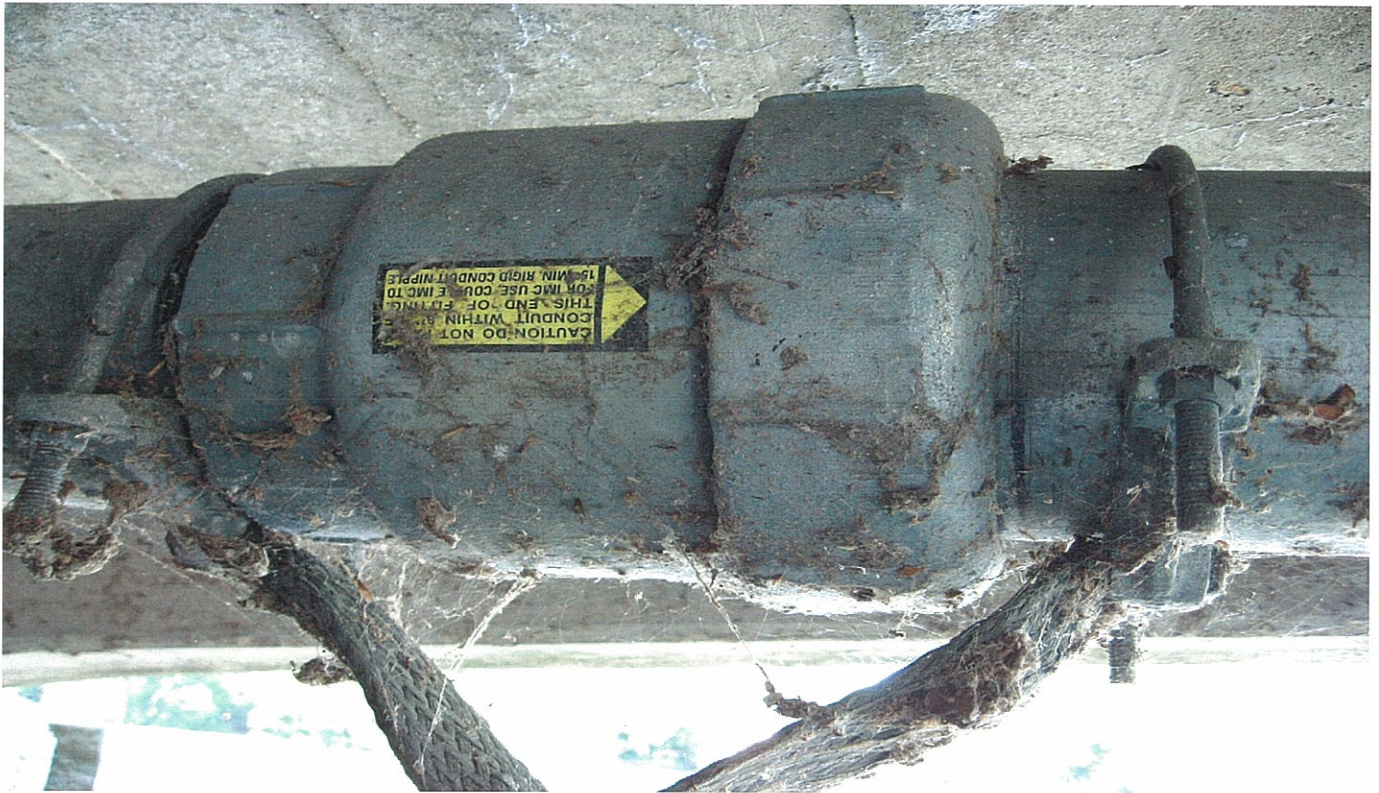
South Abutment Utility Joint

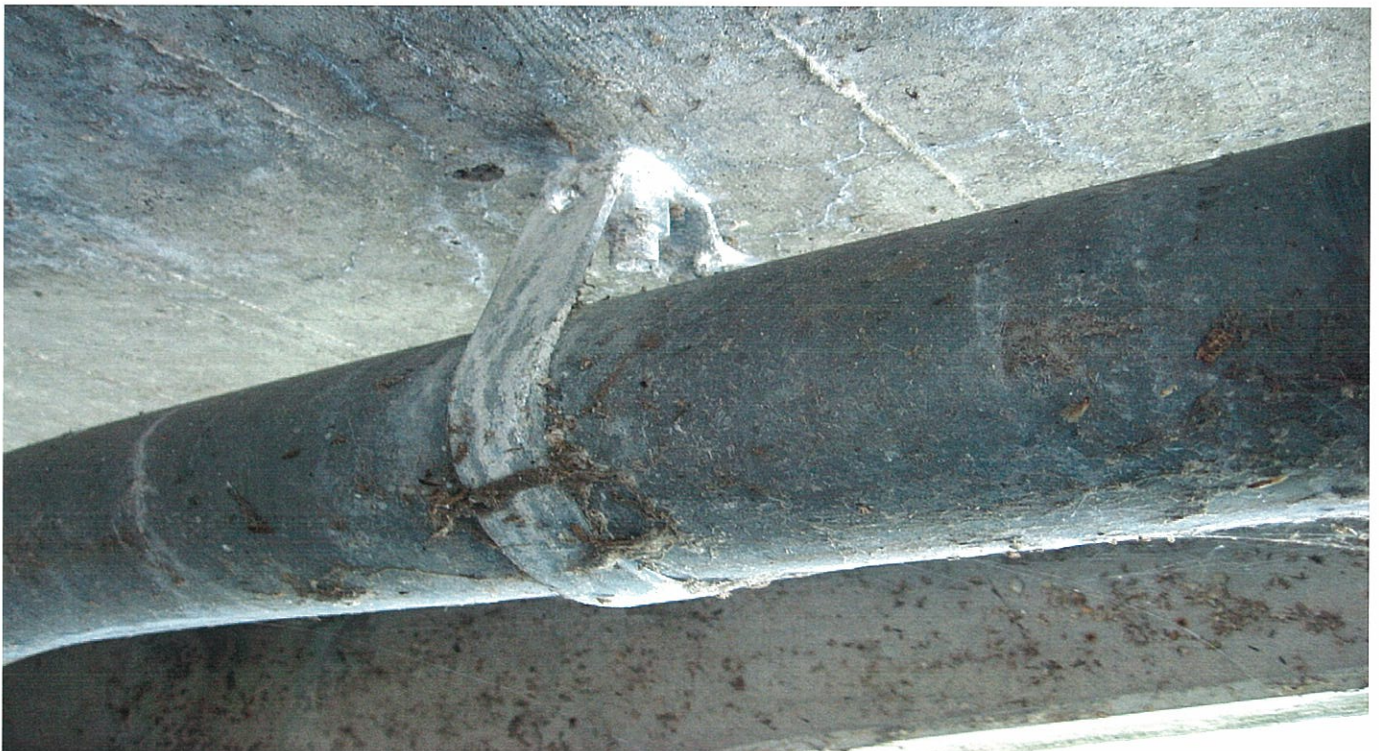
South Abutment Typical Pipe Hanger

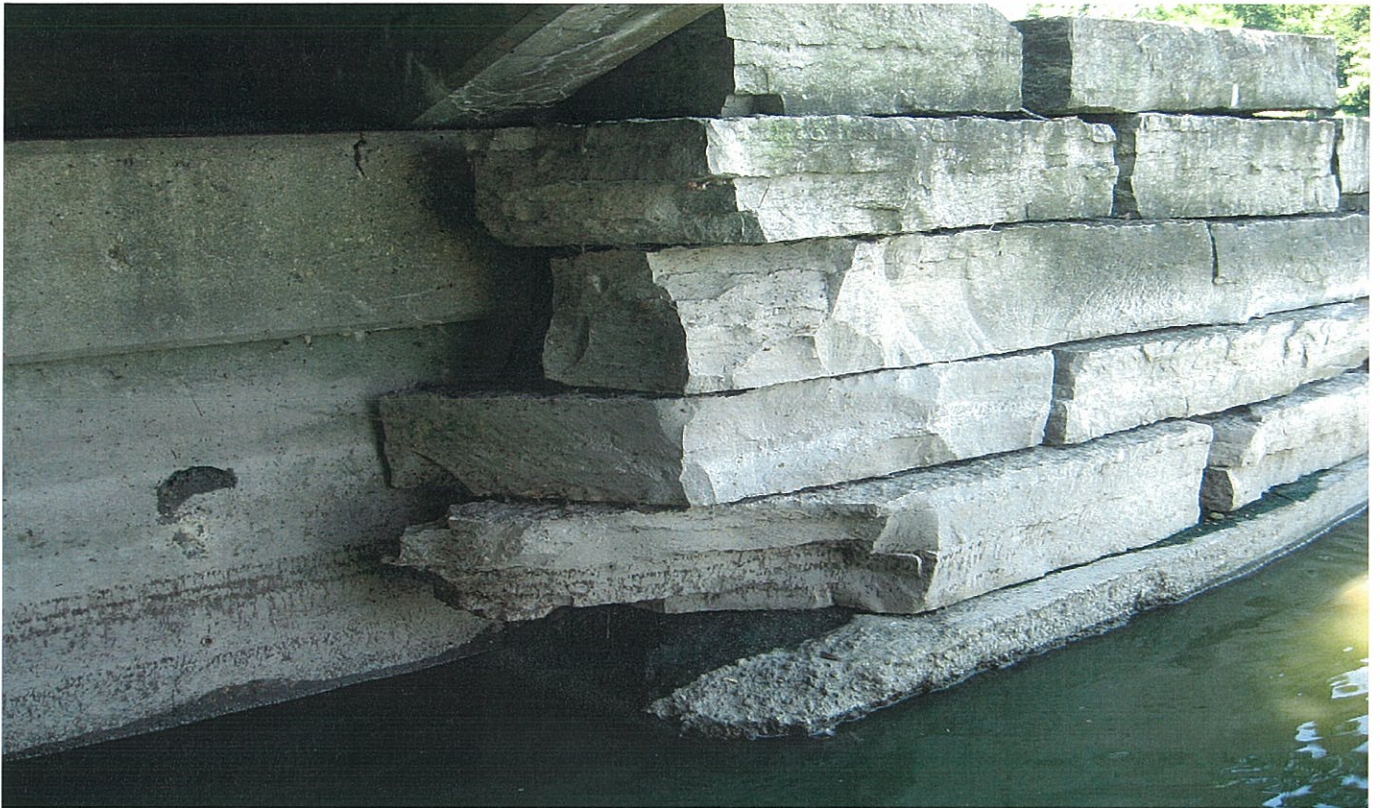
South Abutment Southwest Stone Wall Joints
