# **BRIDGE CONDITION REPORT**

<b>REGION:</b>	<b>1</b>
<b>DISTRICT:</b>	<b>1</b>
<b>ROUTE:</b>	<b>Fox River Trail North Island Bridge</b>
<b>OWNER:</b>	<b>Geneva Park District</b>
<b>COUNTY:</b>	<b>Kane</b>
<b>JOB NUMBER:</b>	<b>P-91-057-07</b>
<b>STRUCTURE NUMBER:</b>	<b>None</b>
<b>LOCATION:</b>	<b>Fox River Trail North Island Bridge (IL 38 at IL 25)</b>
<b>PREPARED BY:</b>	<b>Mark S. Wylie, Farnsworth Group, Inc.</b>
<b>DATE PREPARED:</b>	<b>October 17, 2007</b>
<b>PROPOSED LETTING DATE:</b>	<b>Unknown</b>

Structure Number:	None
County:	Kane
Route Carried:	Fox River Trail
Feature Crossed:	Backwater Channel of Fox River
Section:	06-P0005-00-BR
Station:	12+92.00
Roadway Classification:	Pedestrian/Bike Trail
Design/Posted Speed:	10 mph
ADT (current/design):	N/A
ADTT (current/design):	N/A
DHV:	N/A
Inventory Rating HS:	None
Operating Rating HS:	None
Sufficiency Rating:	None

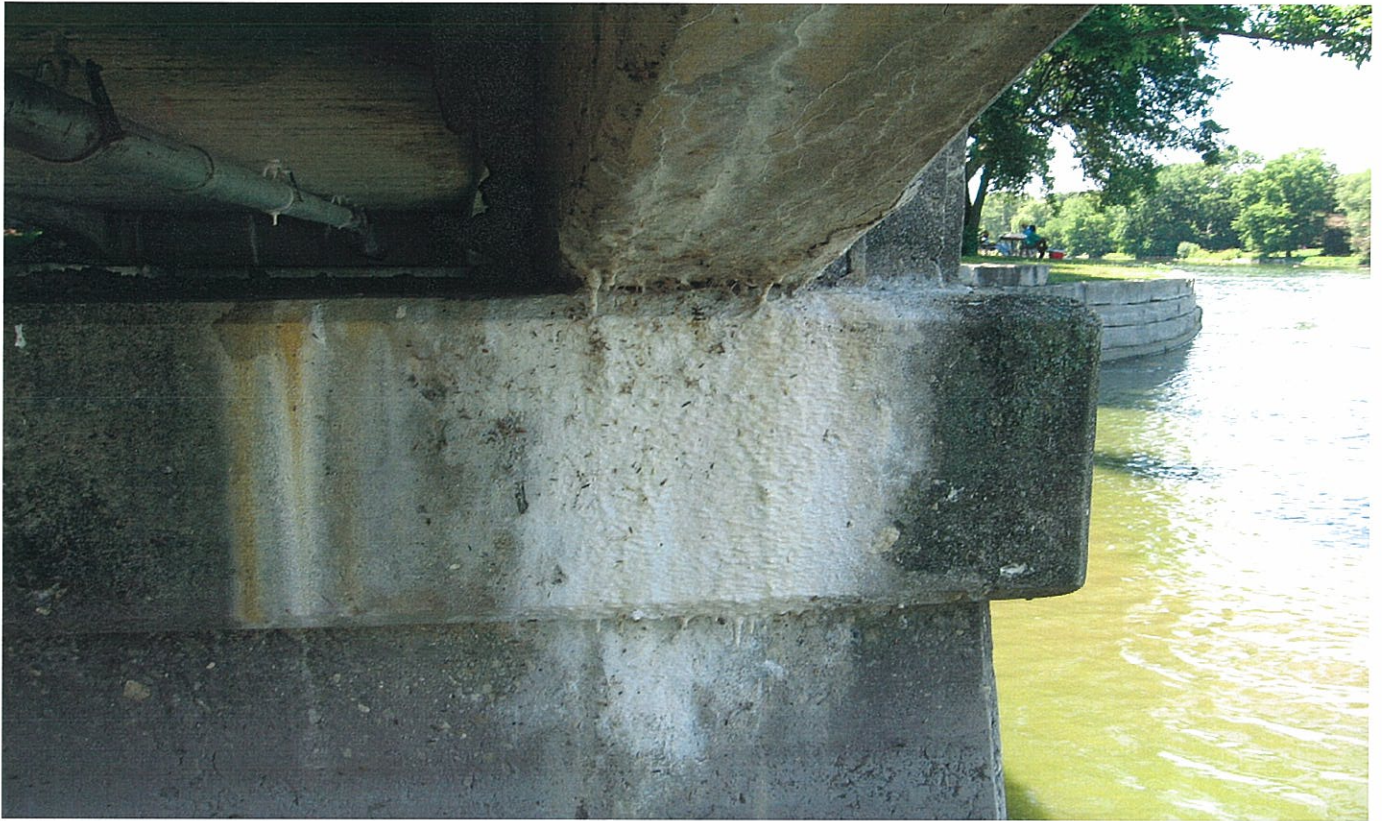
Pier 1 Northwest Beam Pocket (No Pocket)

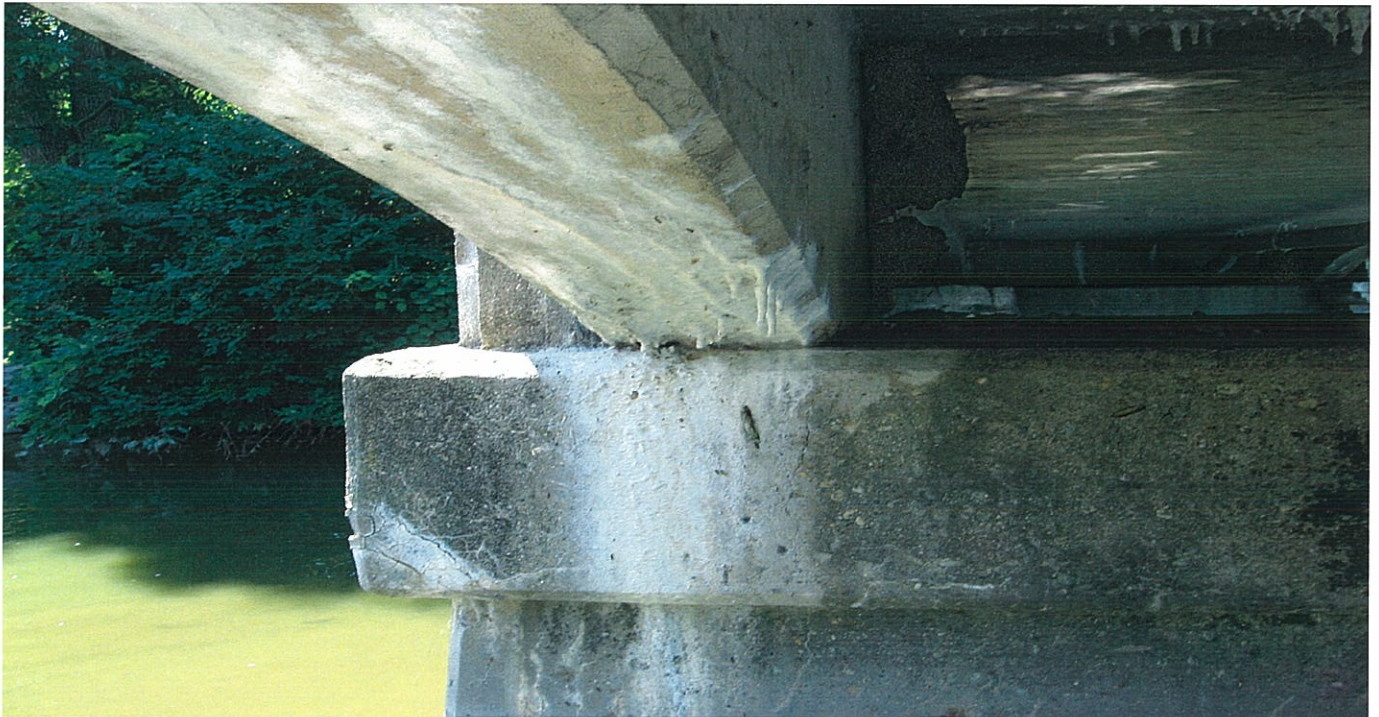
Pier 1 Northeast Beam Pocket (No Pocket)

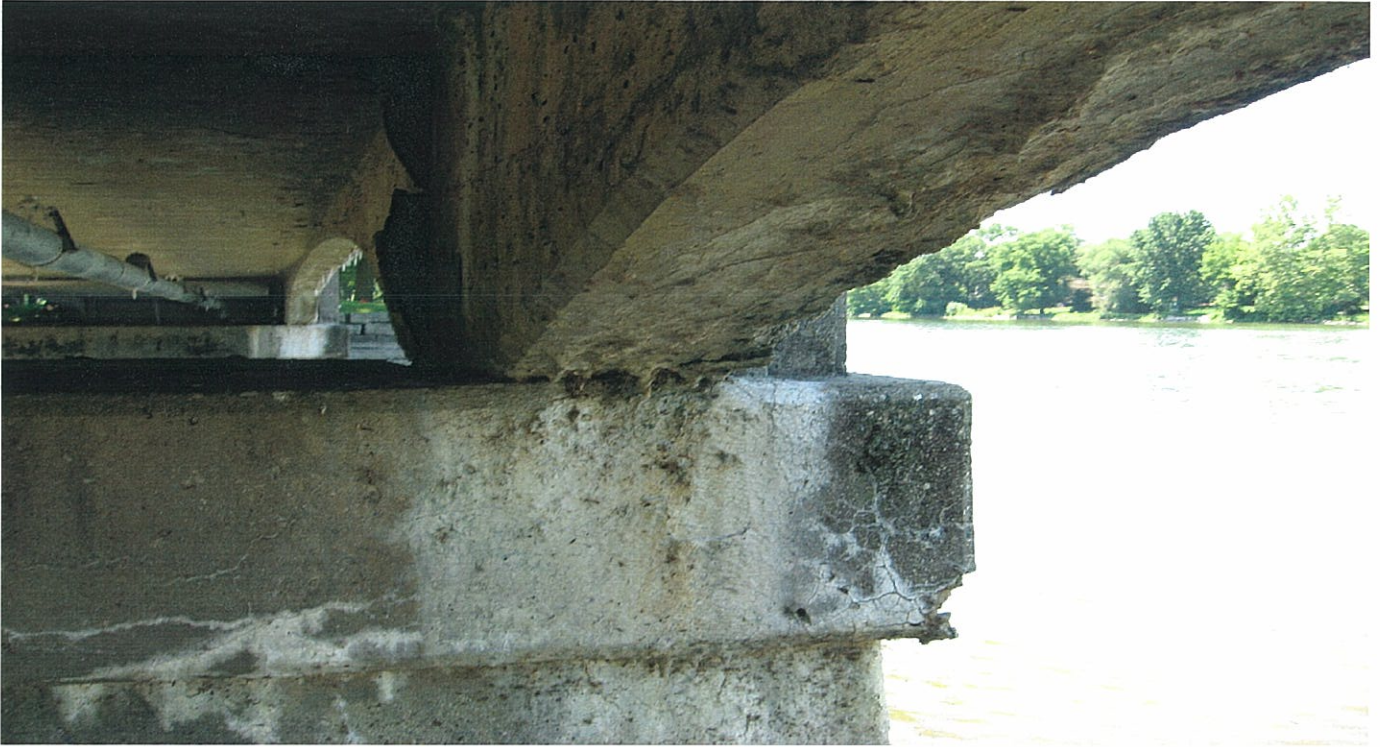
Pier 2 Northwest Beam Pocket (No Pocket)

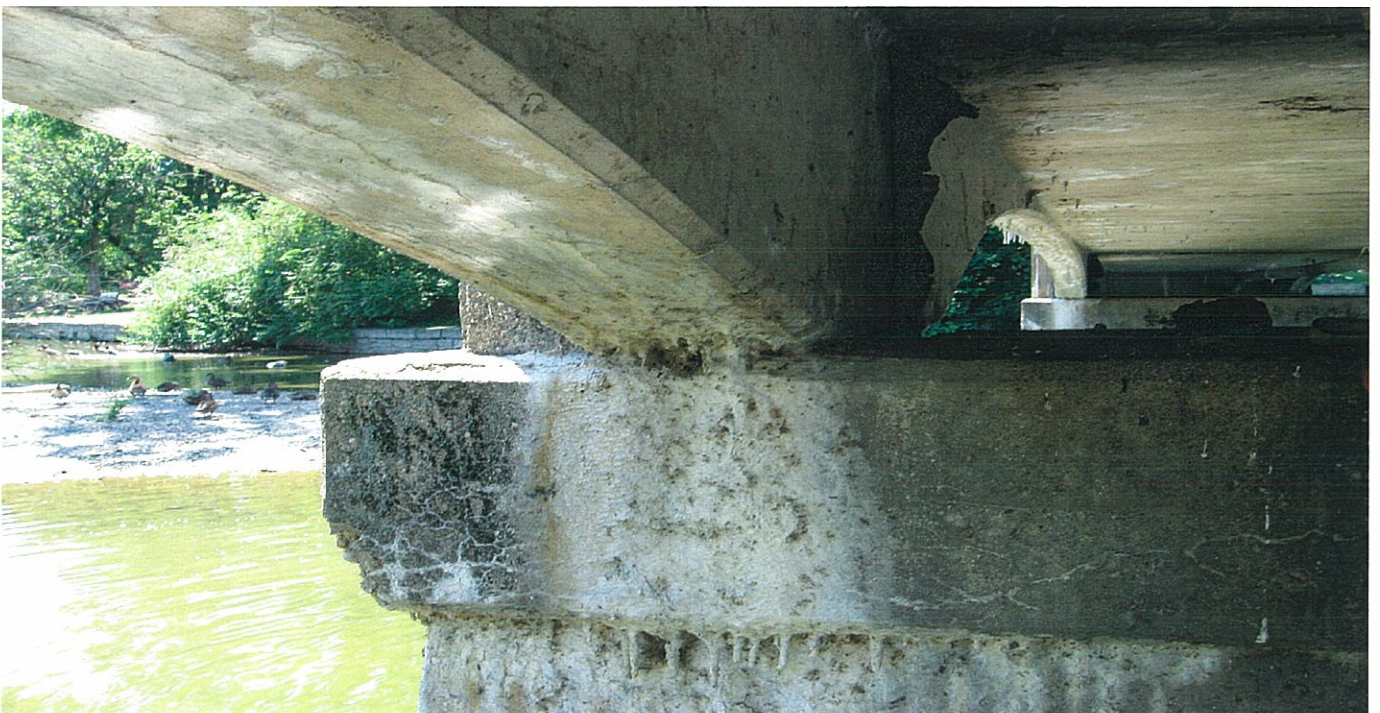
Pier 2 Northeast Beam Pocket (No Pocket)

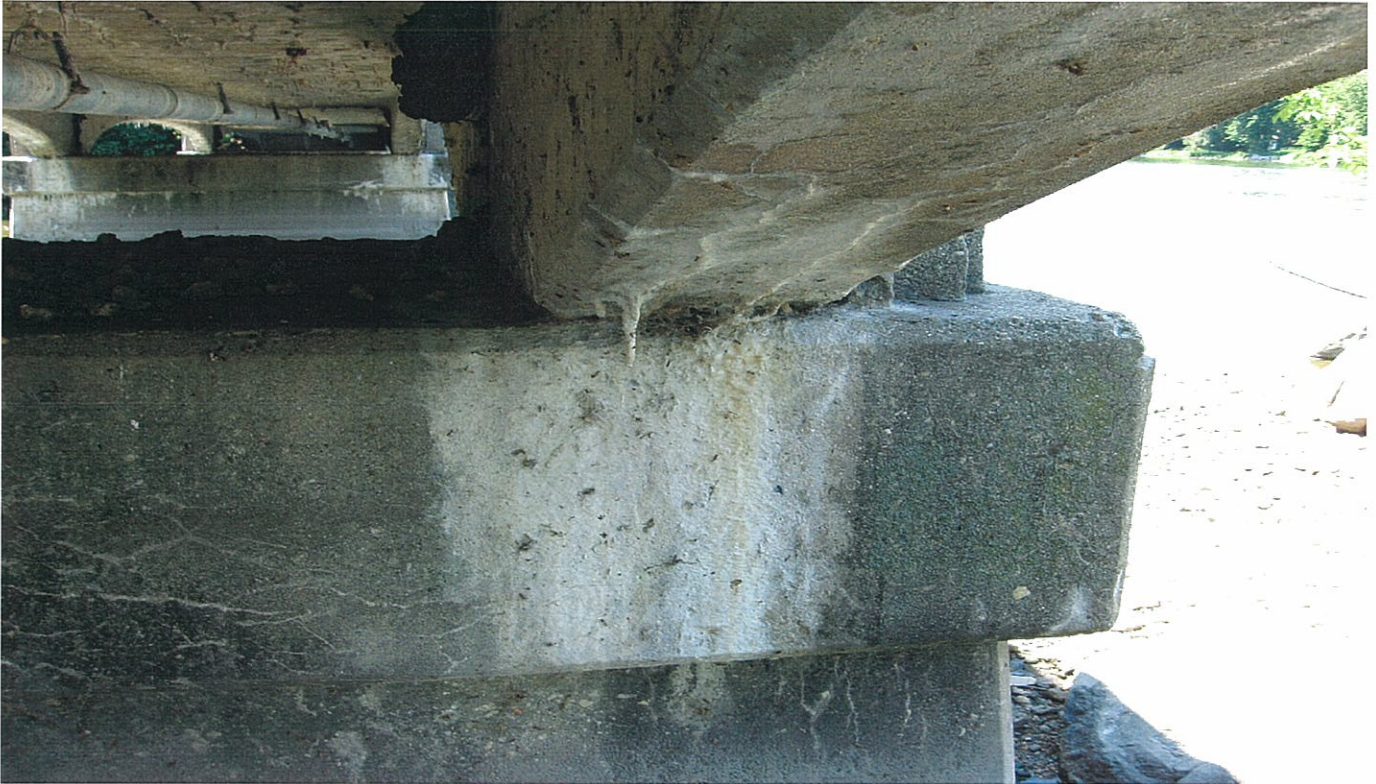
Pier 3 Northwest Beam Pocket (No Pocket)

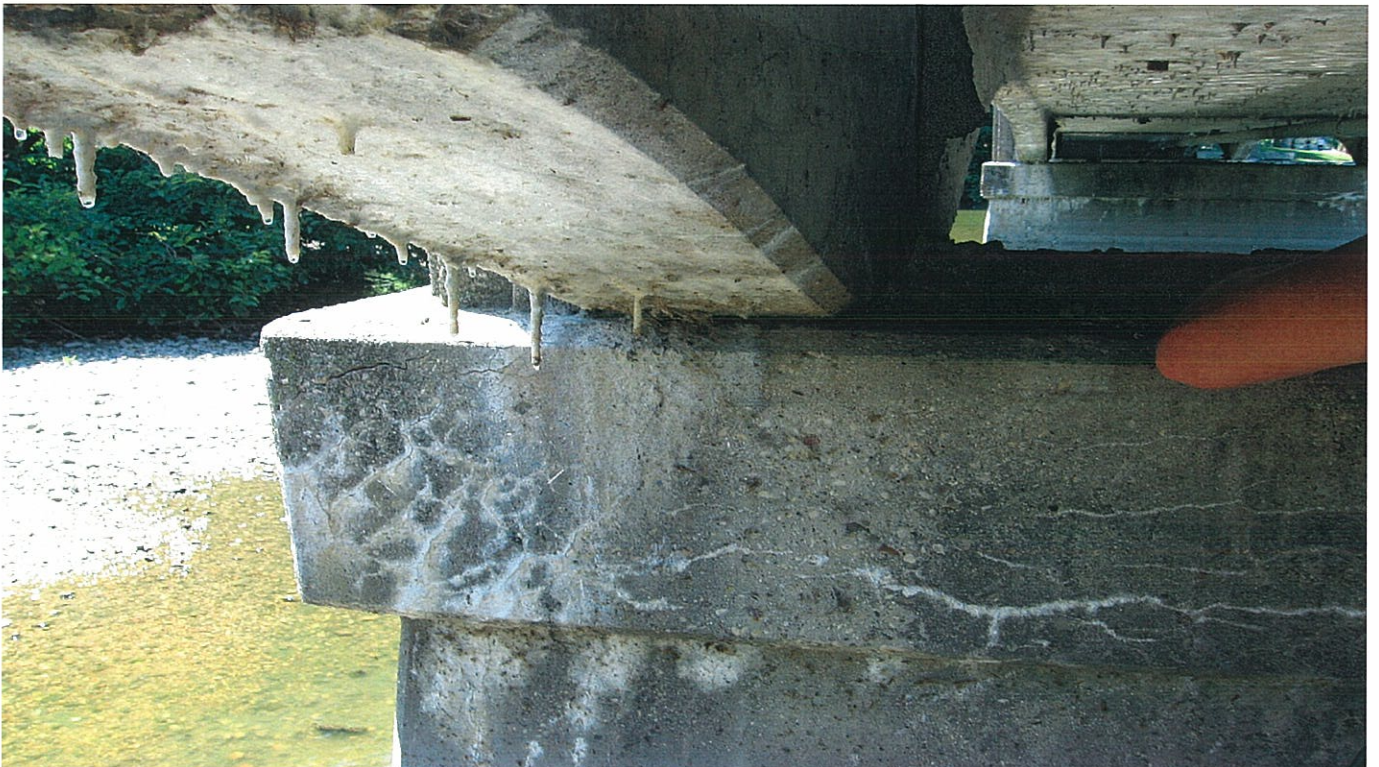
Pier 3 Northeast Beam Pocket (No Pocket)

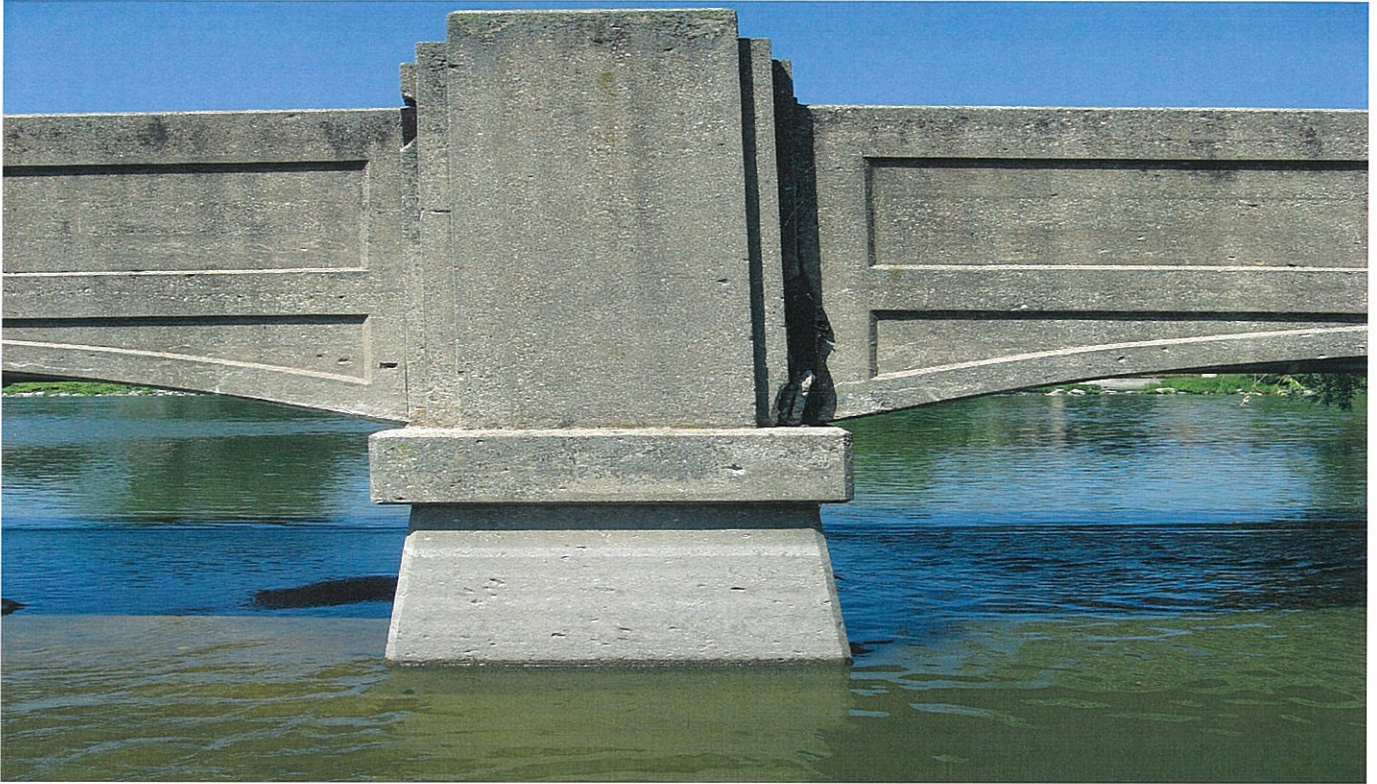
Pier 4 East Face

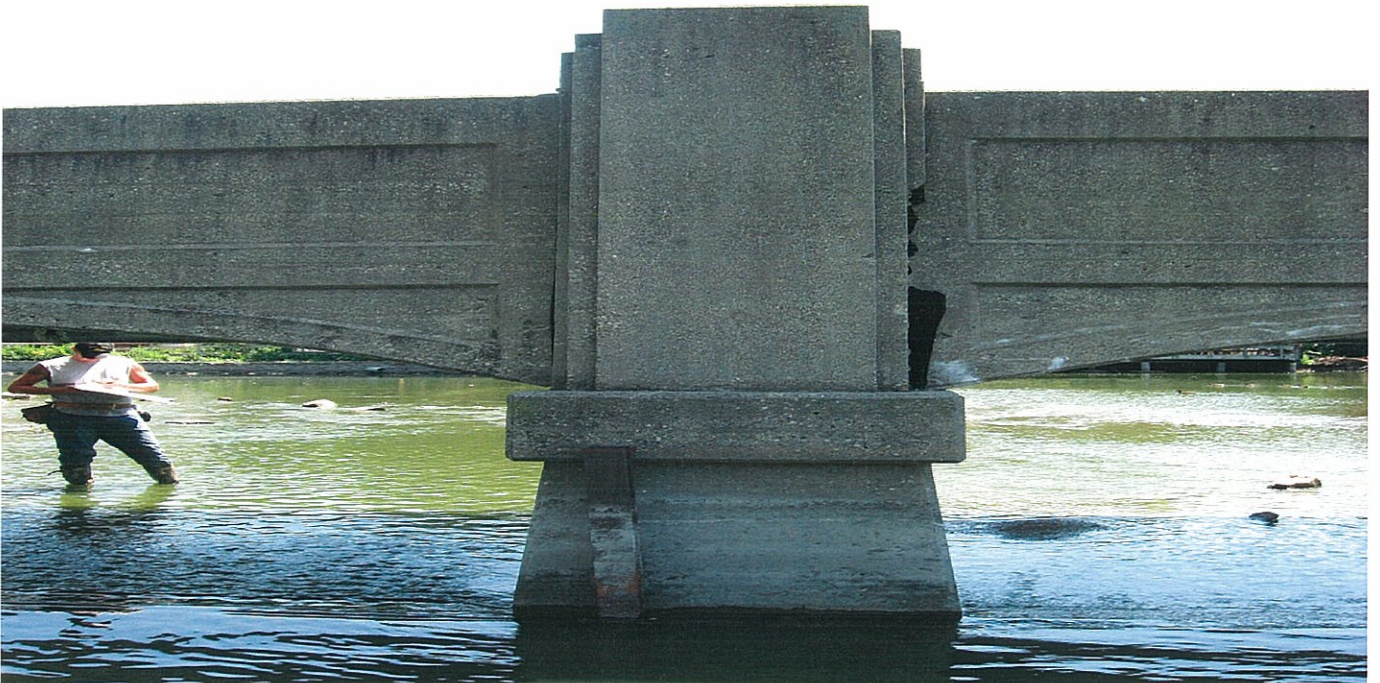
Pier 4 West Face

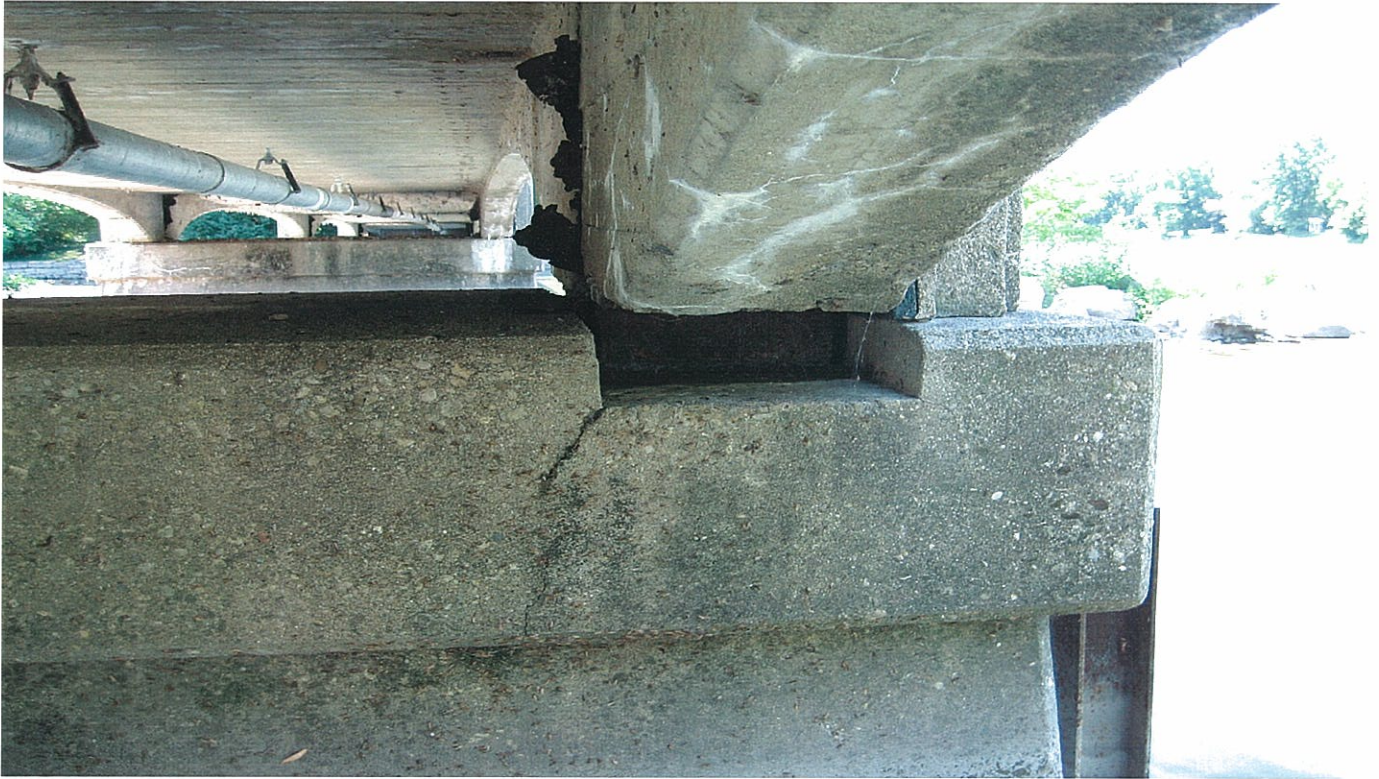
Pier 4 Northwest Beam Pocket

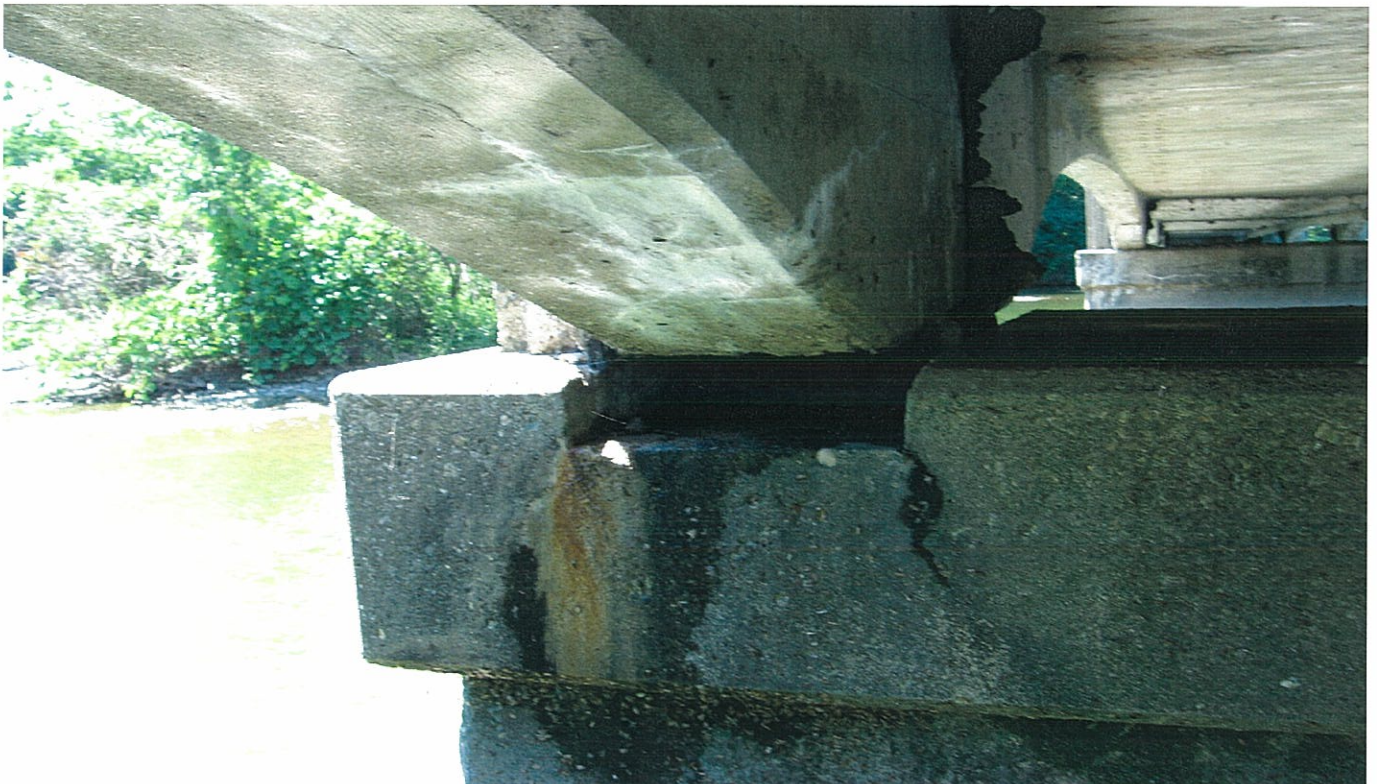
Pier 4 Northeast Beam Pocket

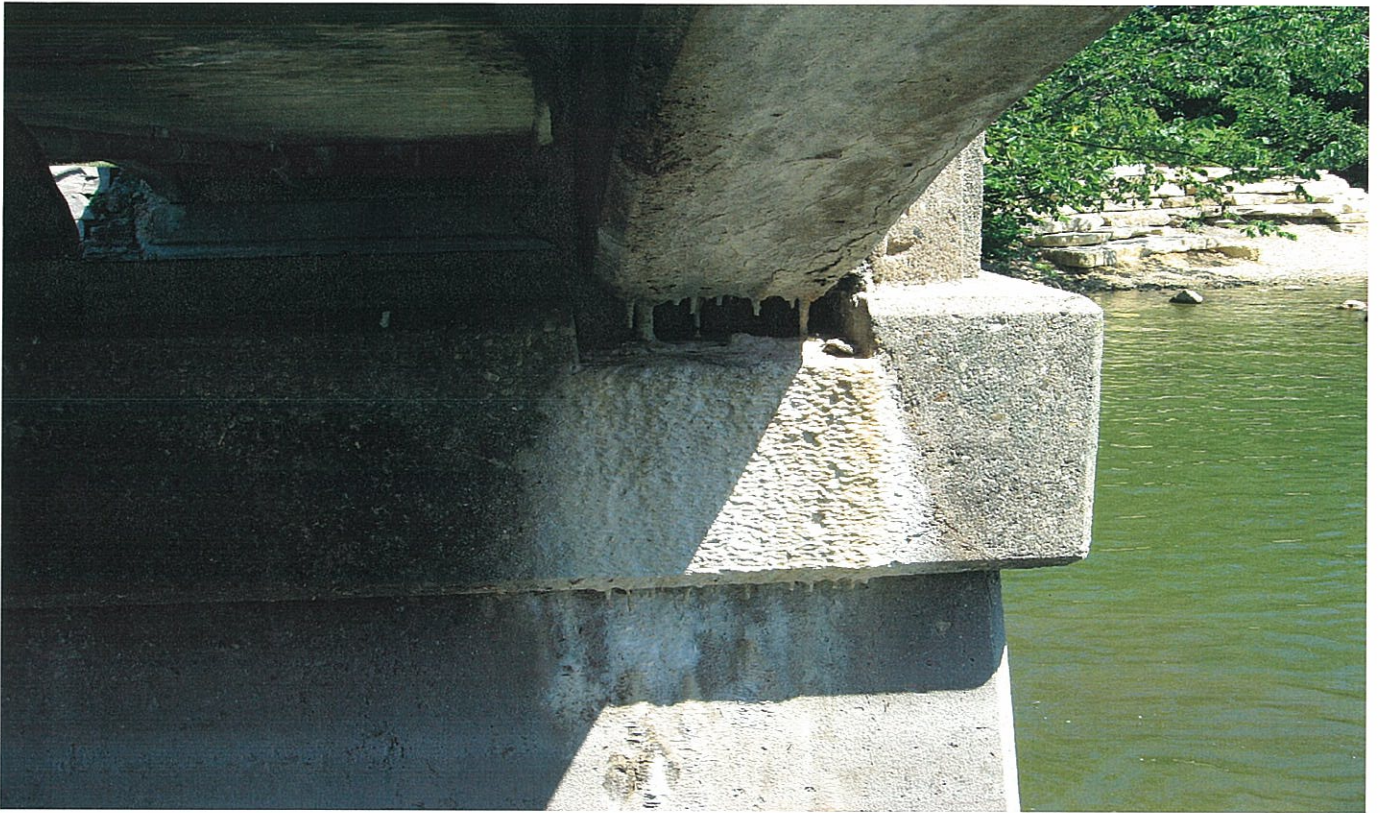
Pier 4 Southeast Beam Pocket

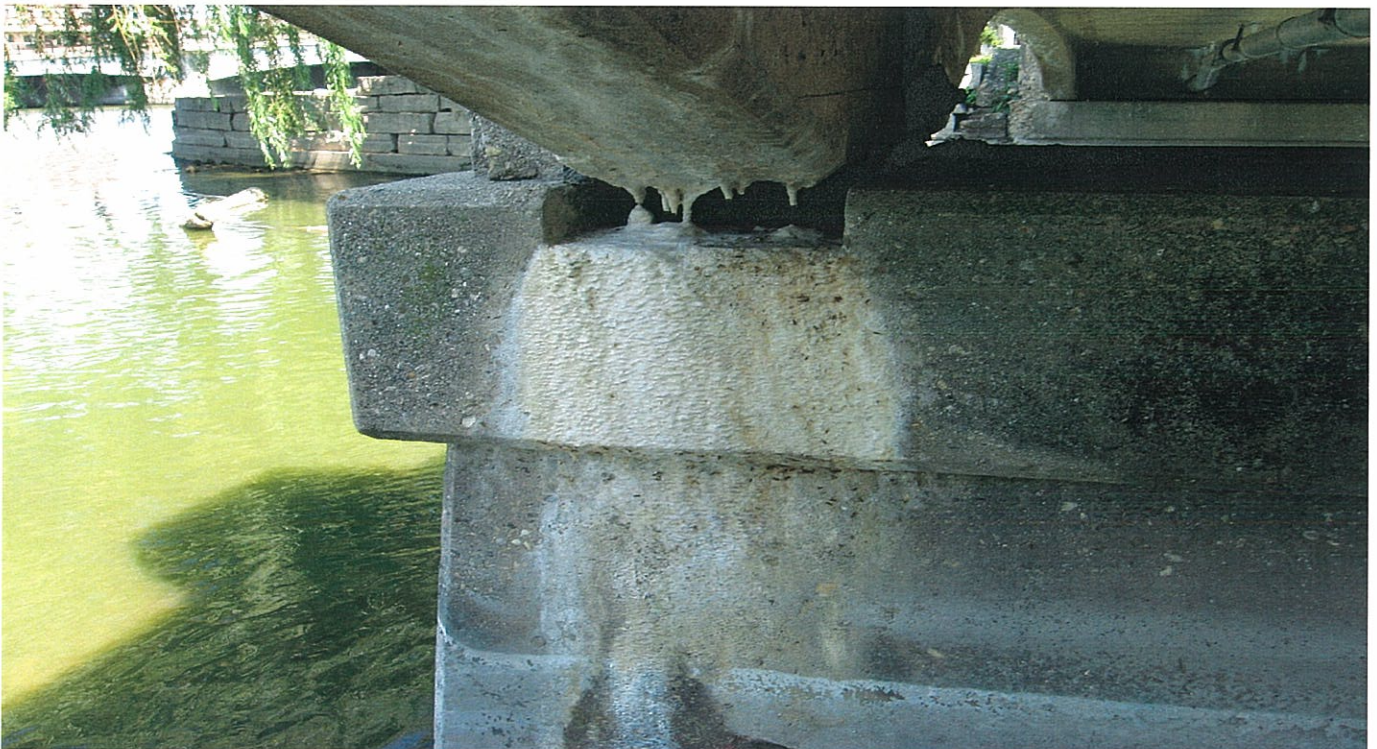
Pier 4 Southwest Beam Pocket

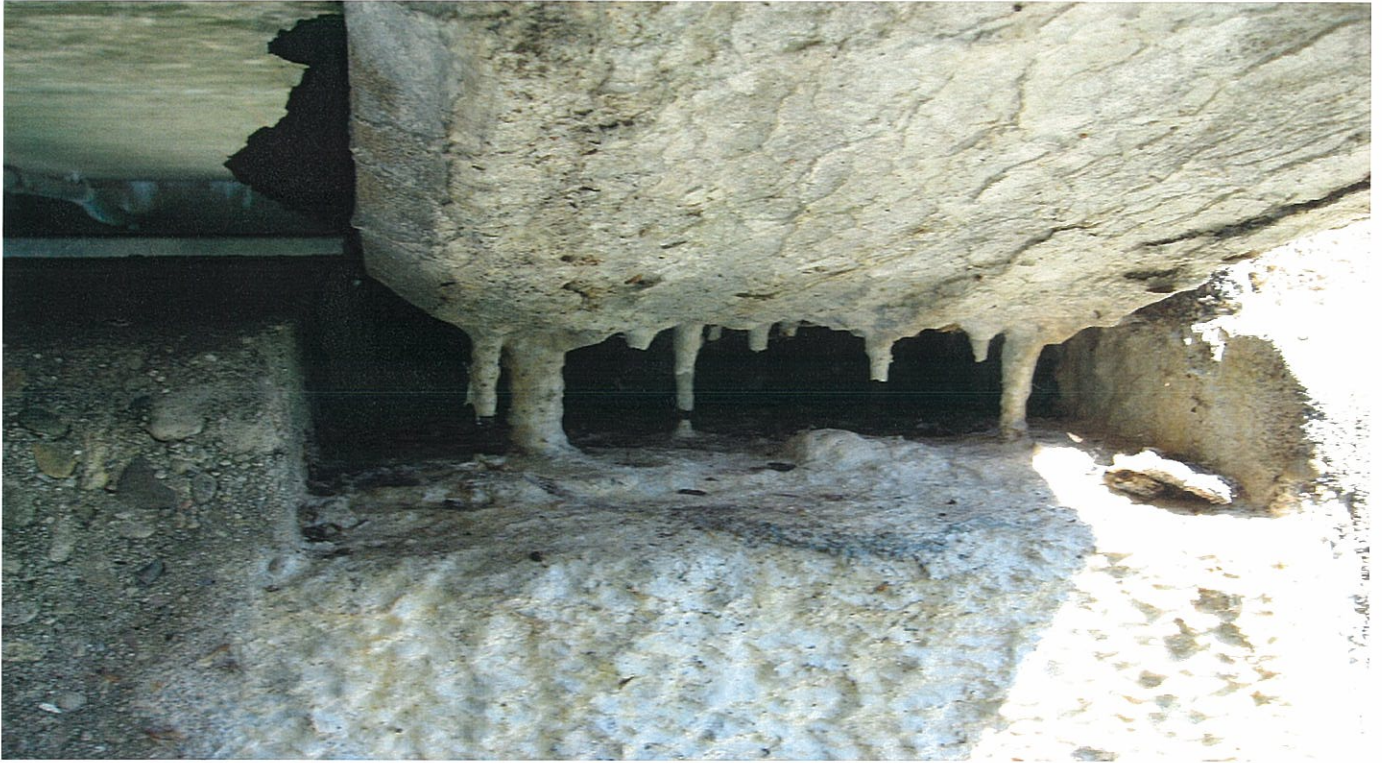
Pier 4 Northeast Beam Pocket Rocker Bearing East Side

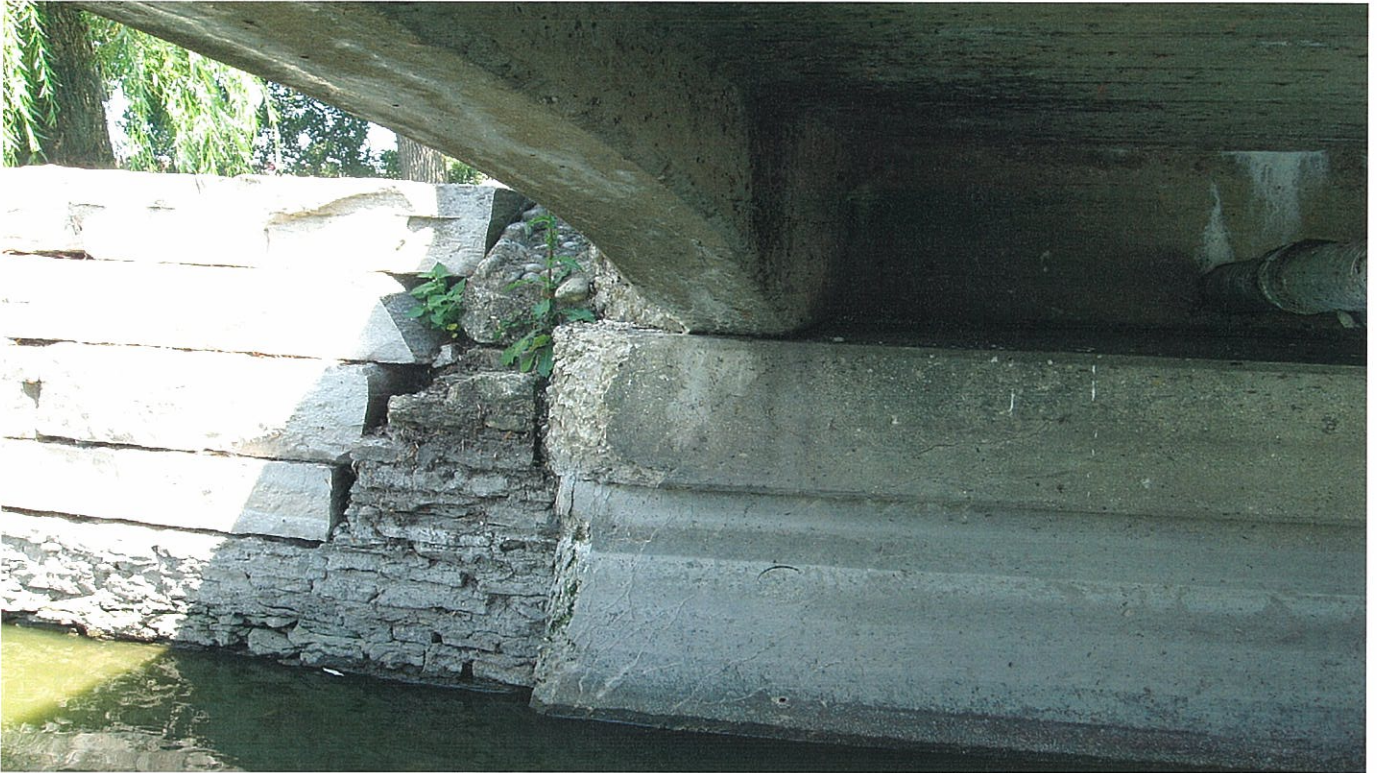
North Abutment West Wall Joins North Abutment

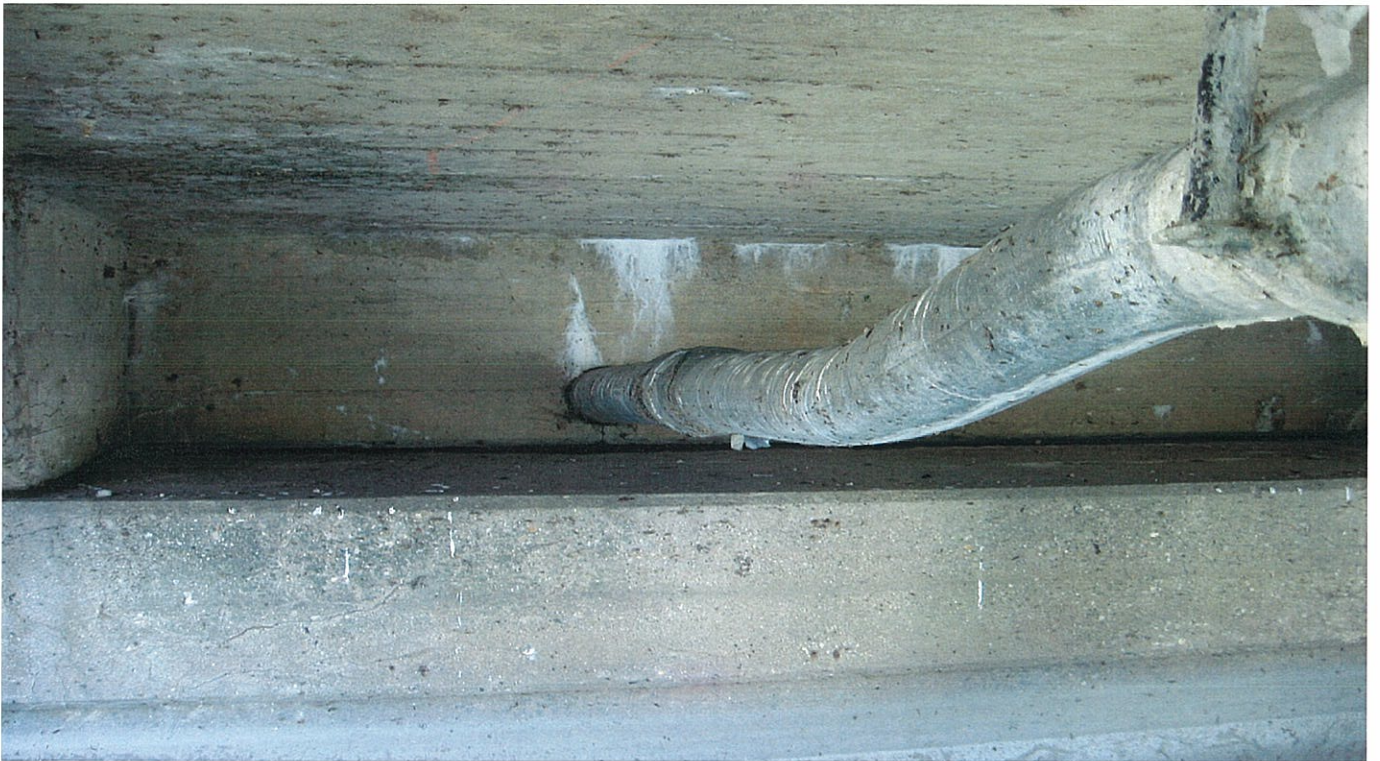
North Abutment w/ Utility Coming Thru Back Wall

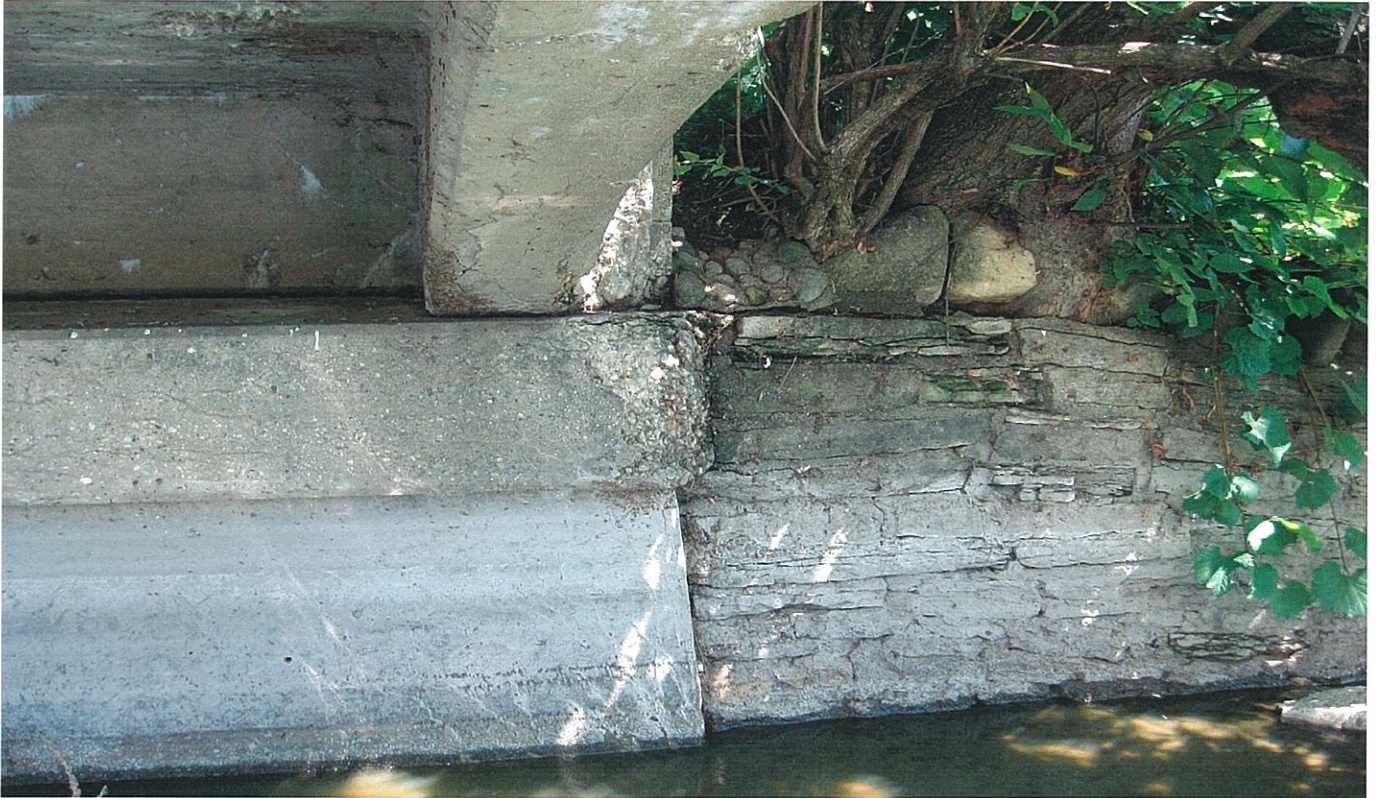
North Abutment West Edge Northwest Wall

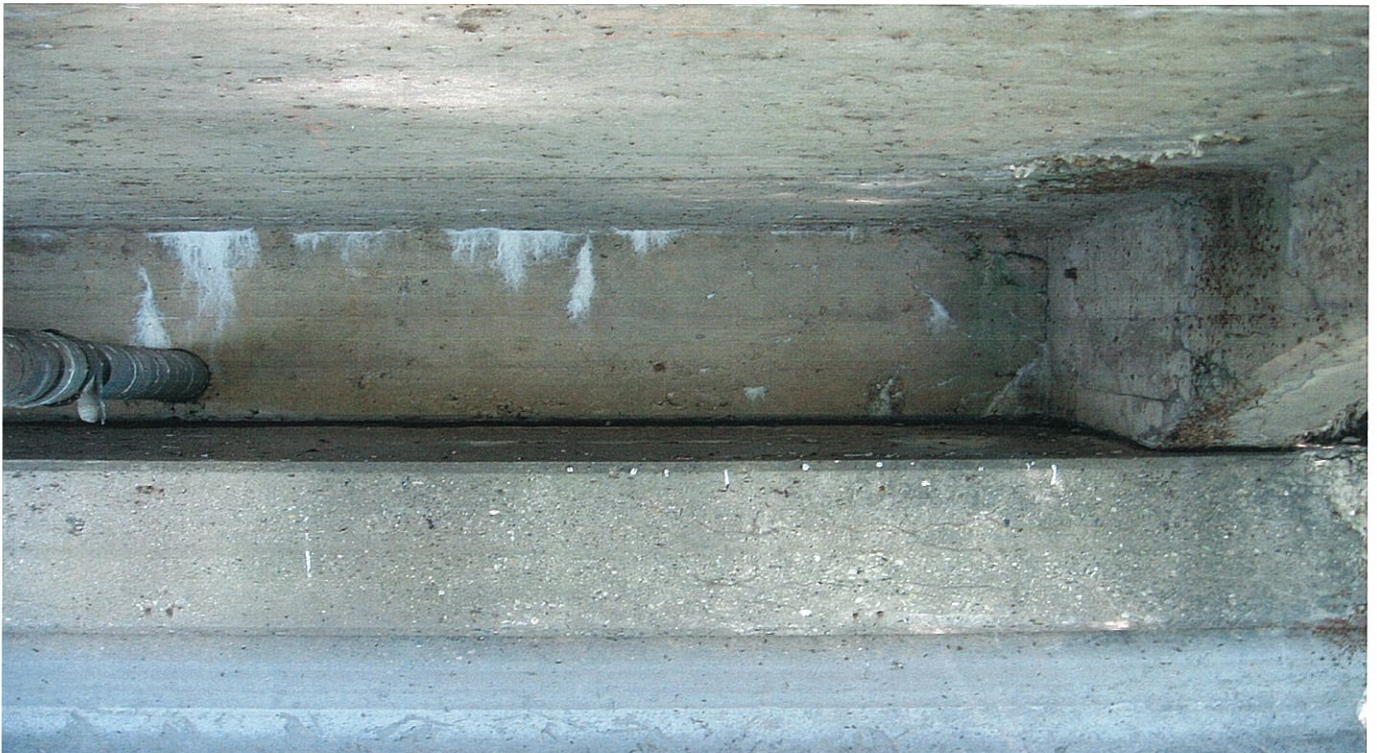
North Abutment East Wall Joint

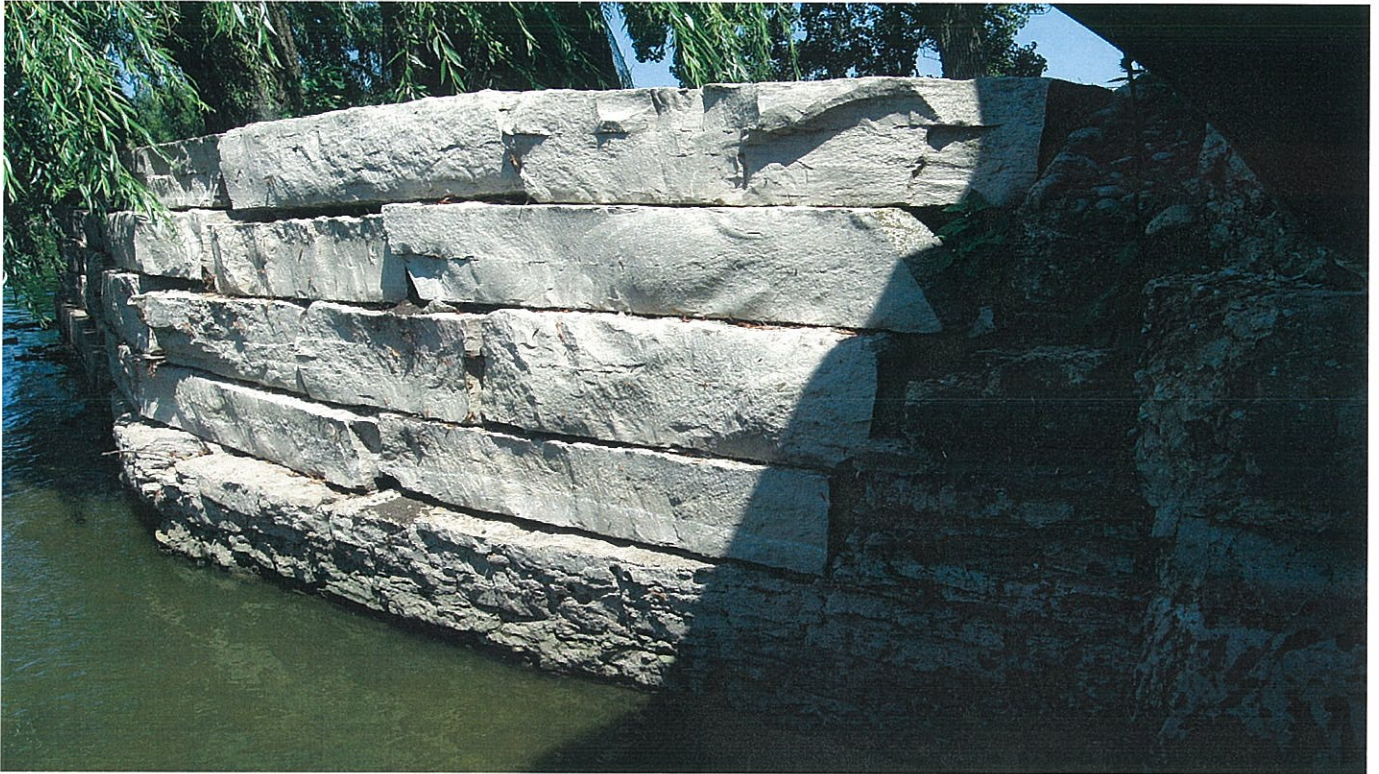
North Abutment Northeast Wall Edge

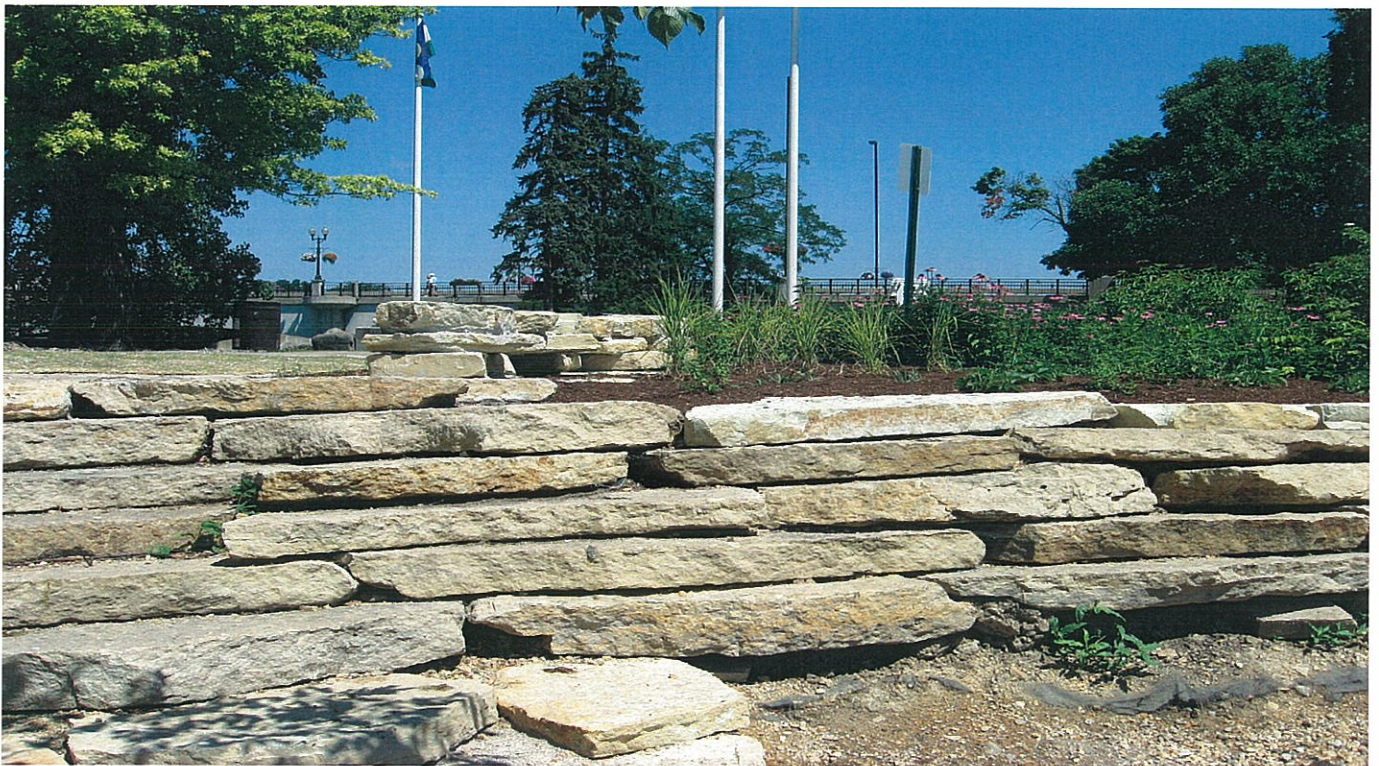
Wall Northeast From Below C27

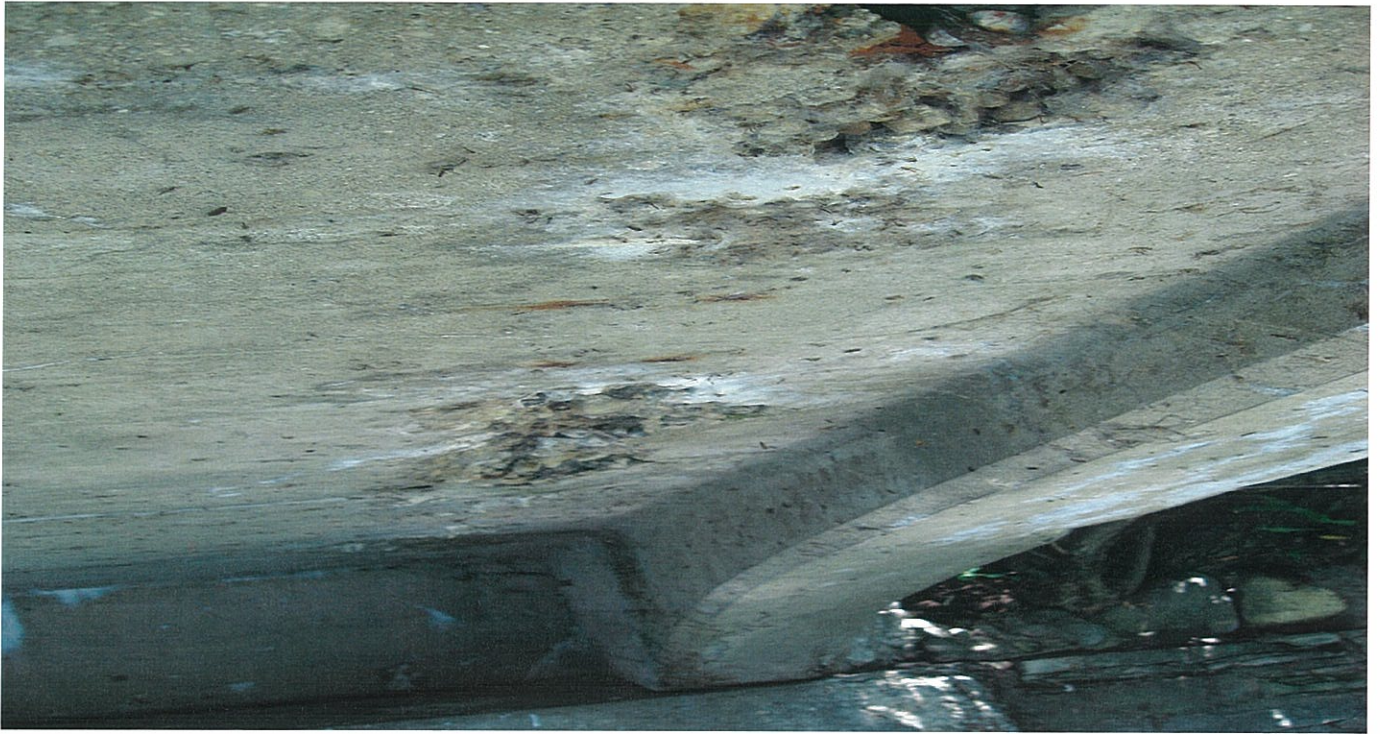
Under Bridge Typical Bad Area Span 5 East Side

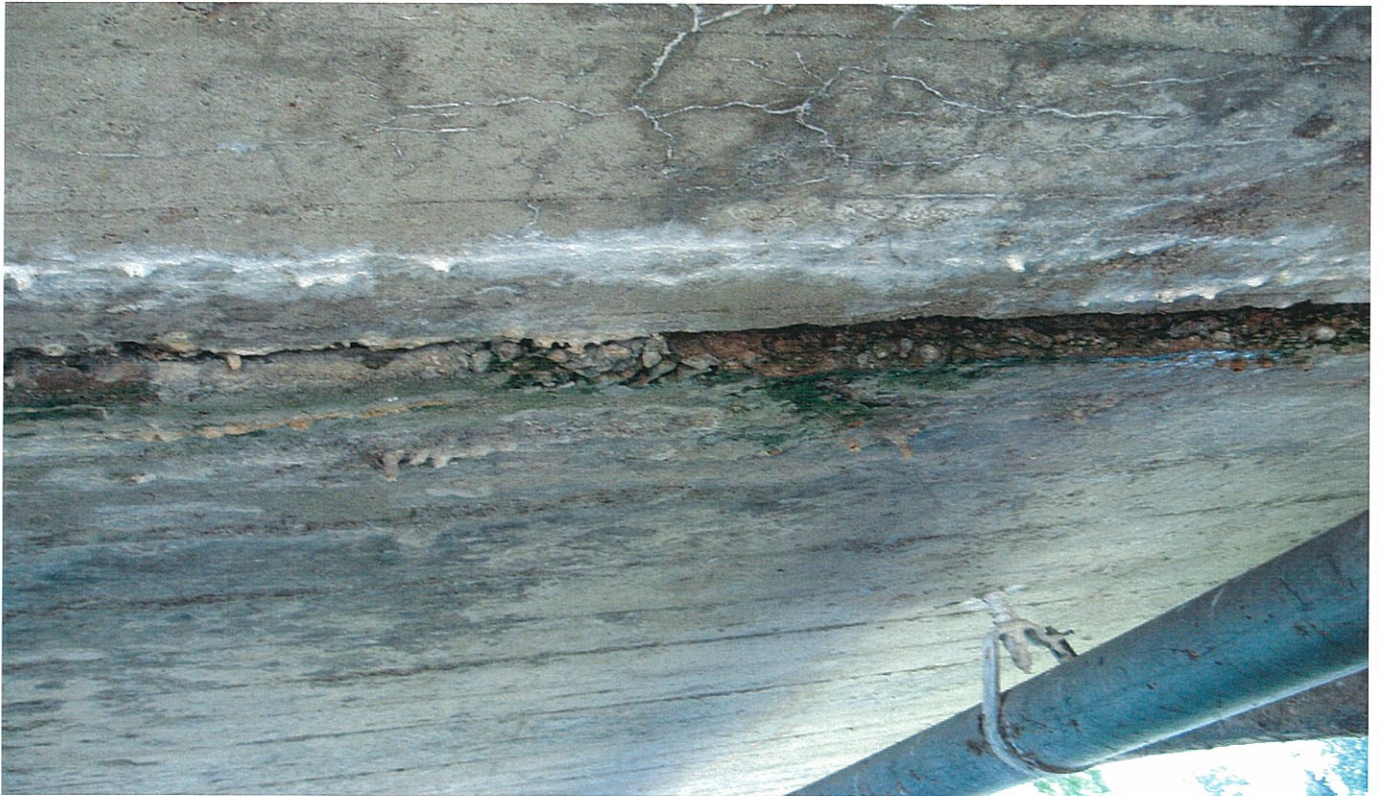
Under Bridge Joint Pier 1 North Side
