# **BRIDGE CONDITION REPORT**

<b>REGION:</b>	<b>1</b>
<b>DISTRICT:</b>	<b>1</b>
<b>ROUTE:</b>	<b>Fox River Trail North Island Bridge</b>
<b>OWNER:</b>	<b>Geneva Park District</b>
<b>COUNTY:</b>	<b>Kane</b>
<b>JOB NUMBER:</b>	<b>P-91-057-07</b>
<b>STRUCTURE NUMBER:</b>	<b>None</b>
<b>LOCATION:</b>	<b>Fox River Trail North Island Bridge (IL 38 at IL 25)</b>
<b>PREPARED BY:</b>	<b>Mark S. Wylie, Farnsworth Group, Inc.</b>
<b>DATE PREPARED:</b>	<b>October 17, 2007</b>
<b>PROPOSED LETTING DATE:</b>	<b>Unknown</b>

Structure Number:	None
County:	Kane
Route Carried:	Fox River Trail
Feature Crossed:	Backwater Channel of Fox River
Section:	06-P0005-00-BR
Station:	12+92.00
Roadway Classification:	Pedestrian/Bike Trail
Design/Posted Speed:	10 mph
ADT (current/design):	N/A
ADTT (current/design):	N/A
DHV:	N/A
Inventory Rating HS:	None
Operating Rating HS:	None
Sufficiency Rating:	None

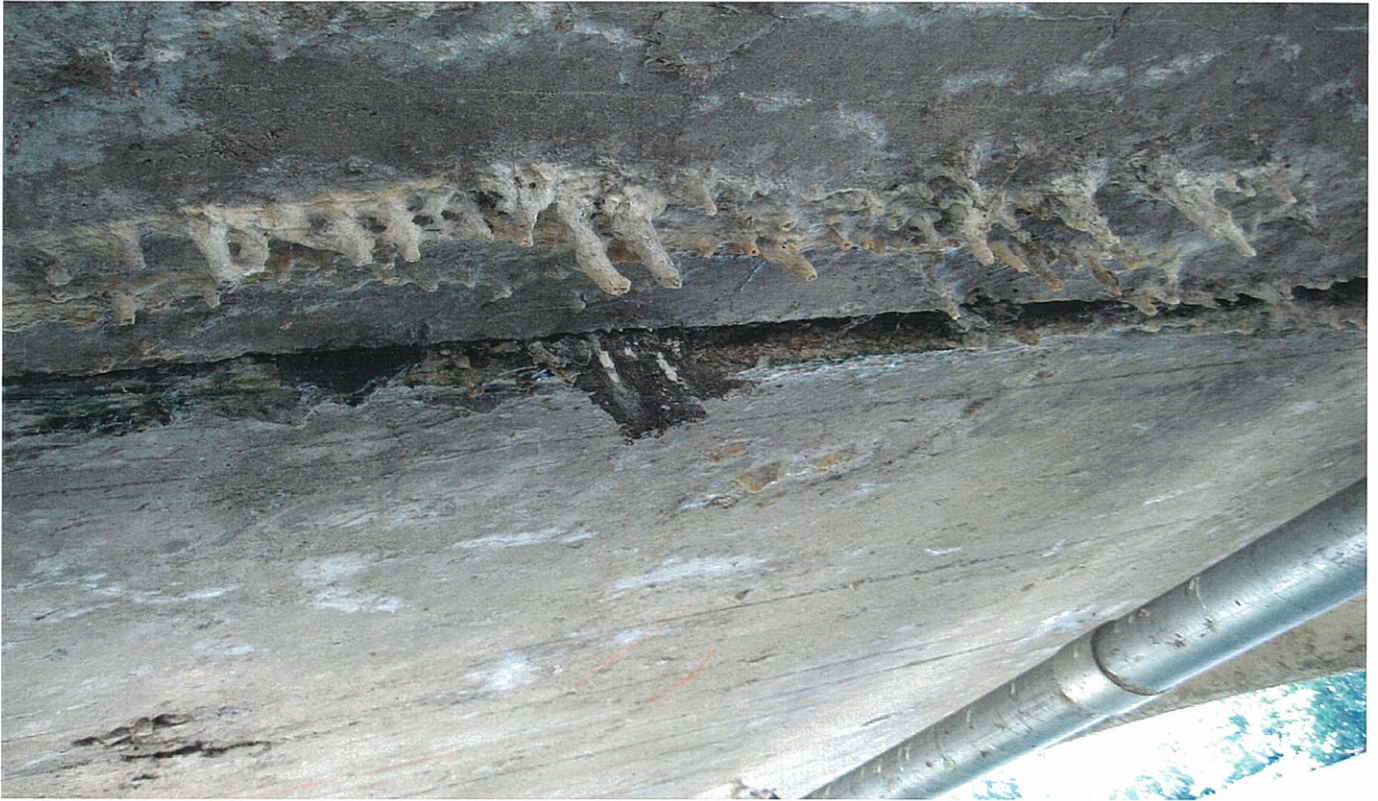
Under Bridge Joint Pier 2 North Side

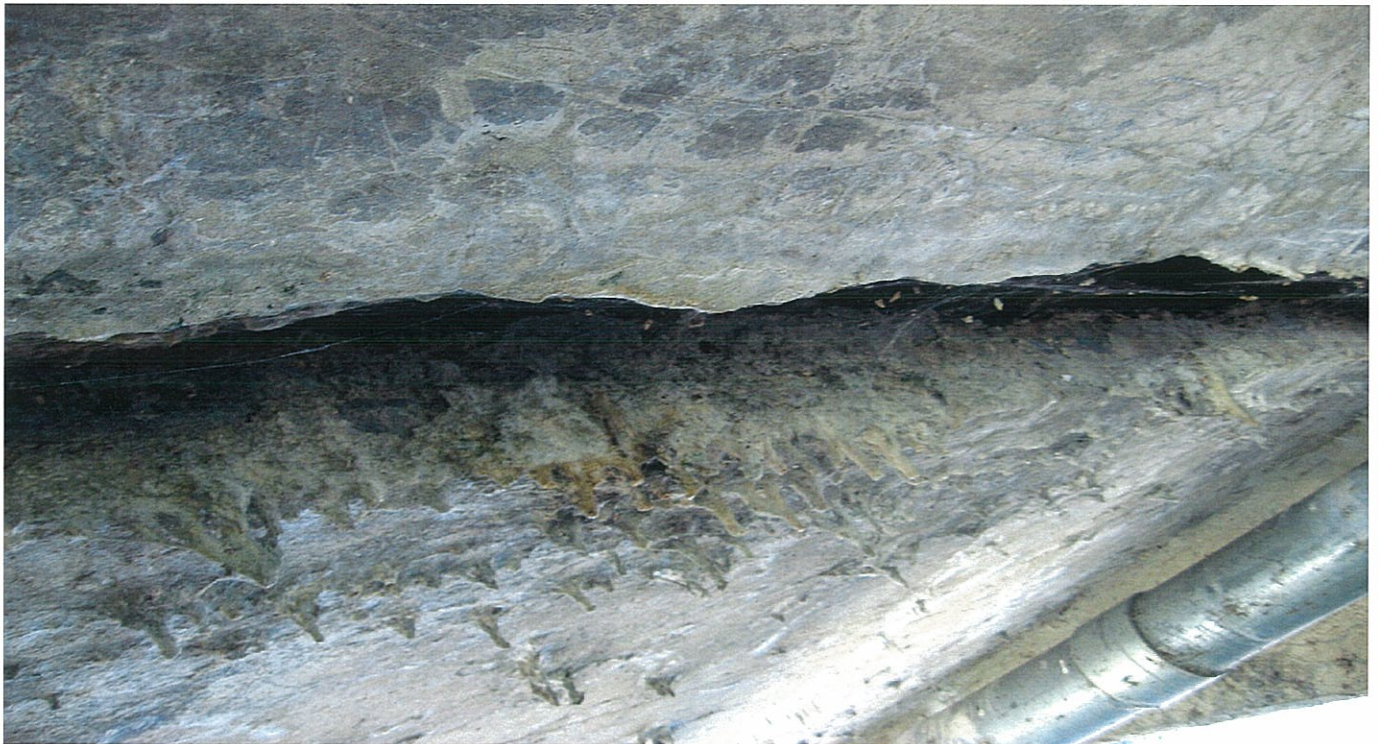
Under Bridge Joint Pier 3 North Side

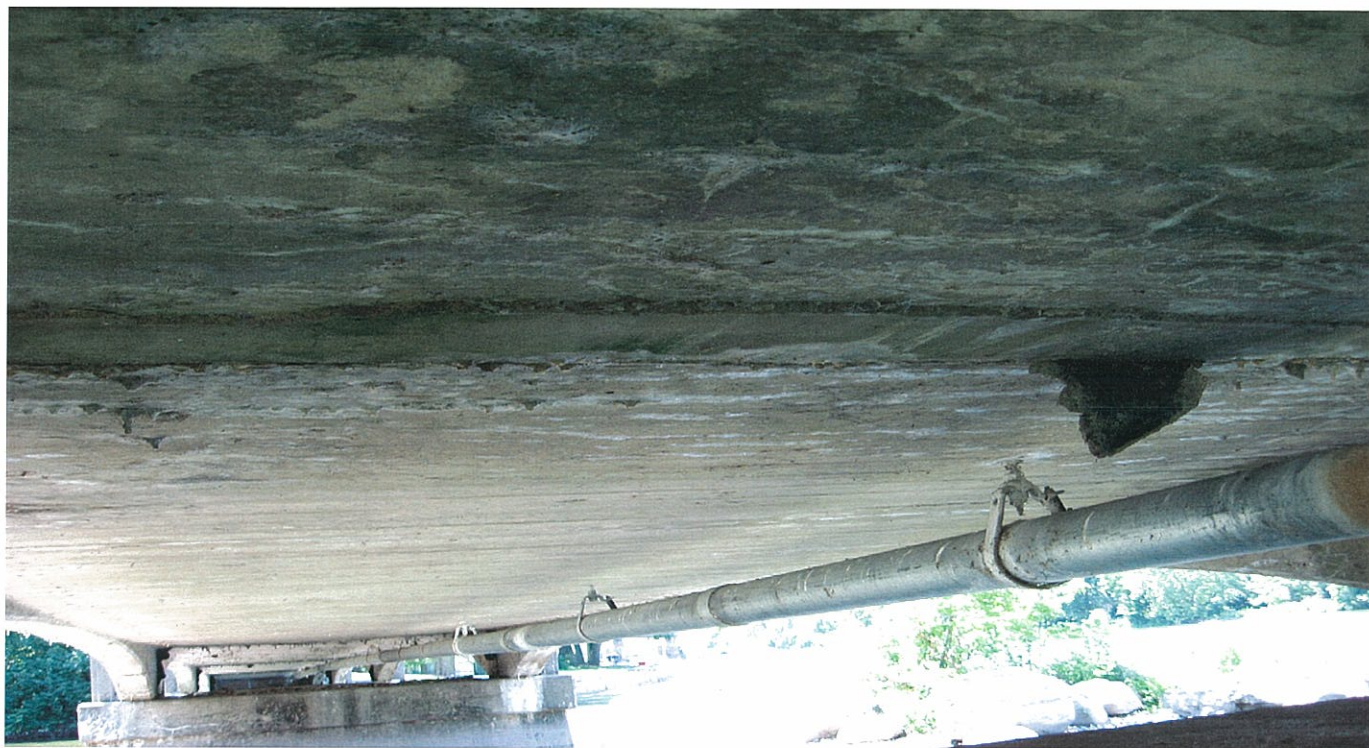
Under Bridge Lack of Joint Pier 4

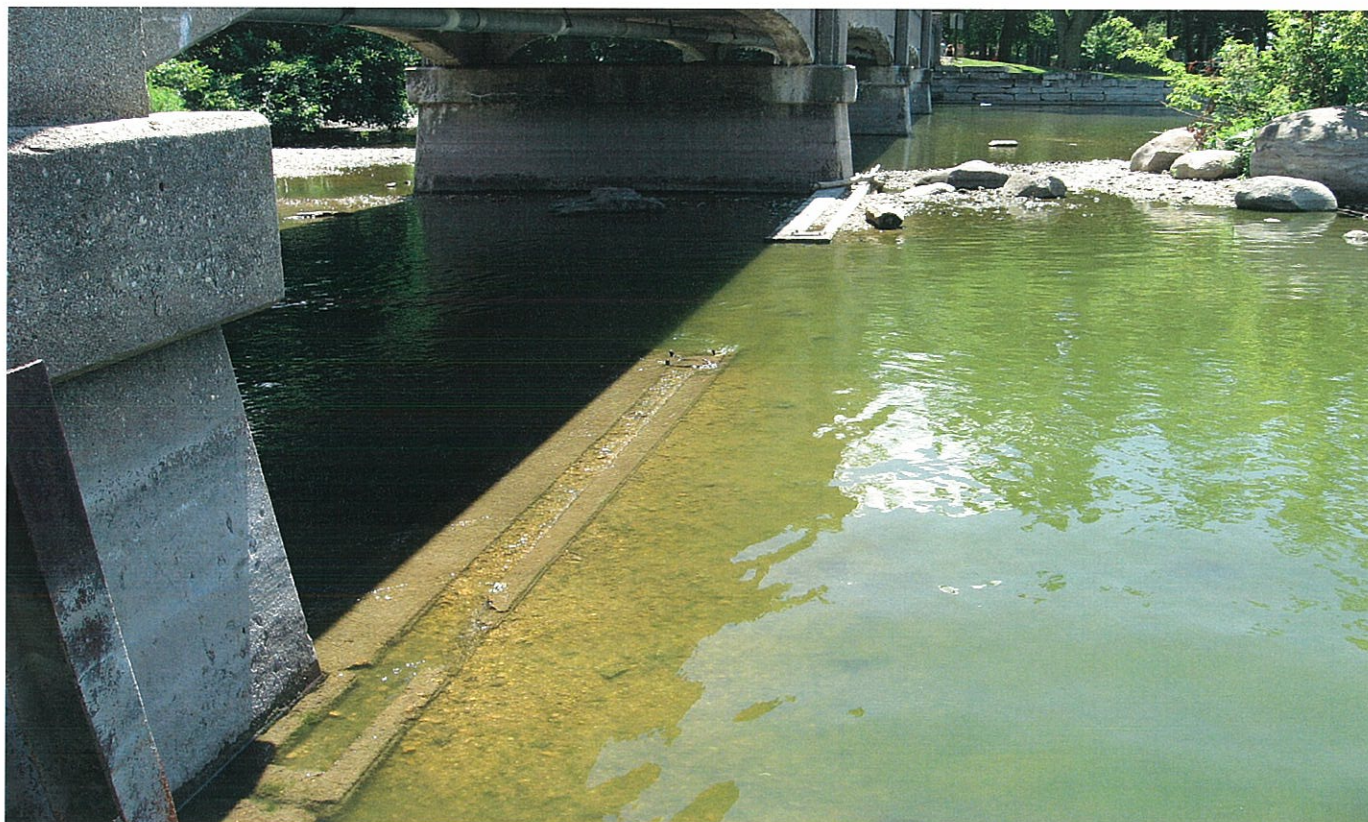
Under Bridge West Side Bridge Old Flood Walls

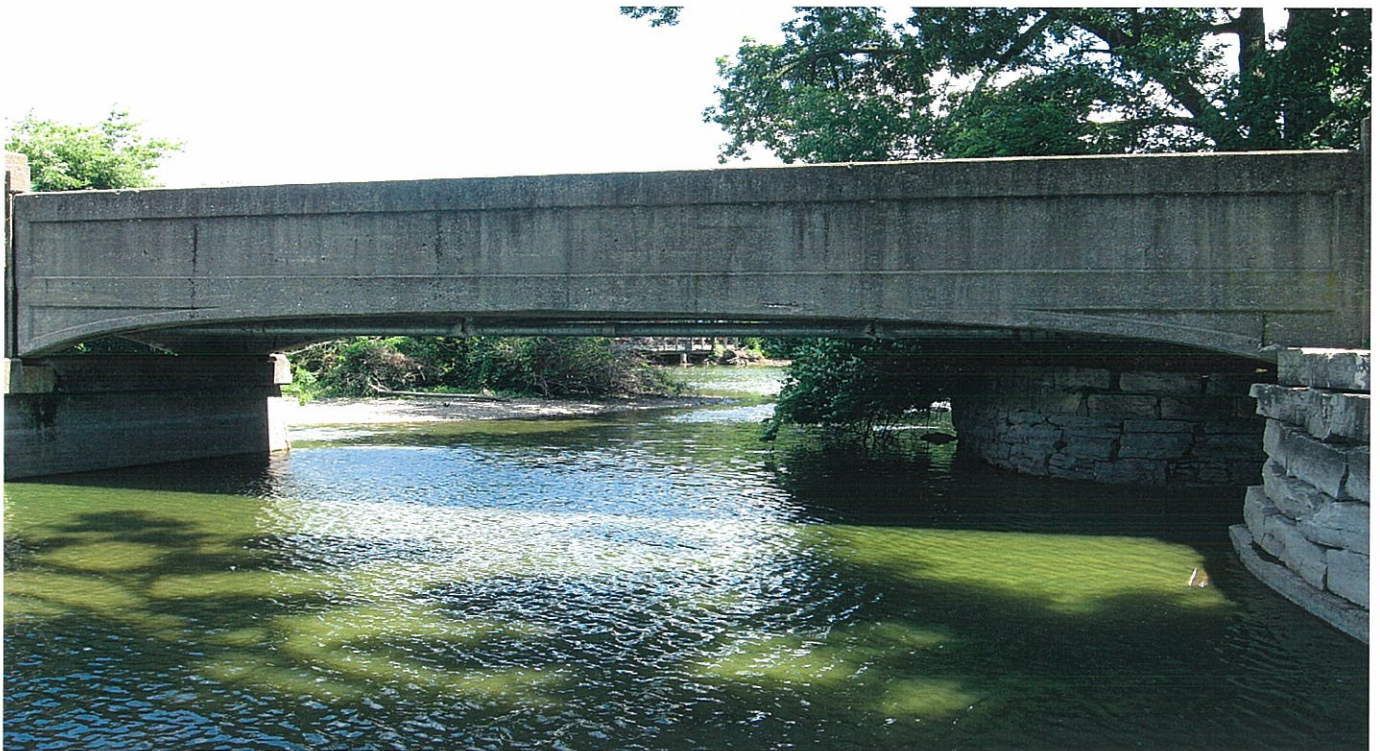
Under Bridge Span 1 West Side Outer Typical West Side Beam/Parapet

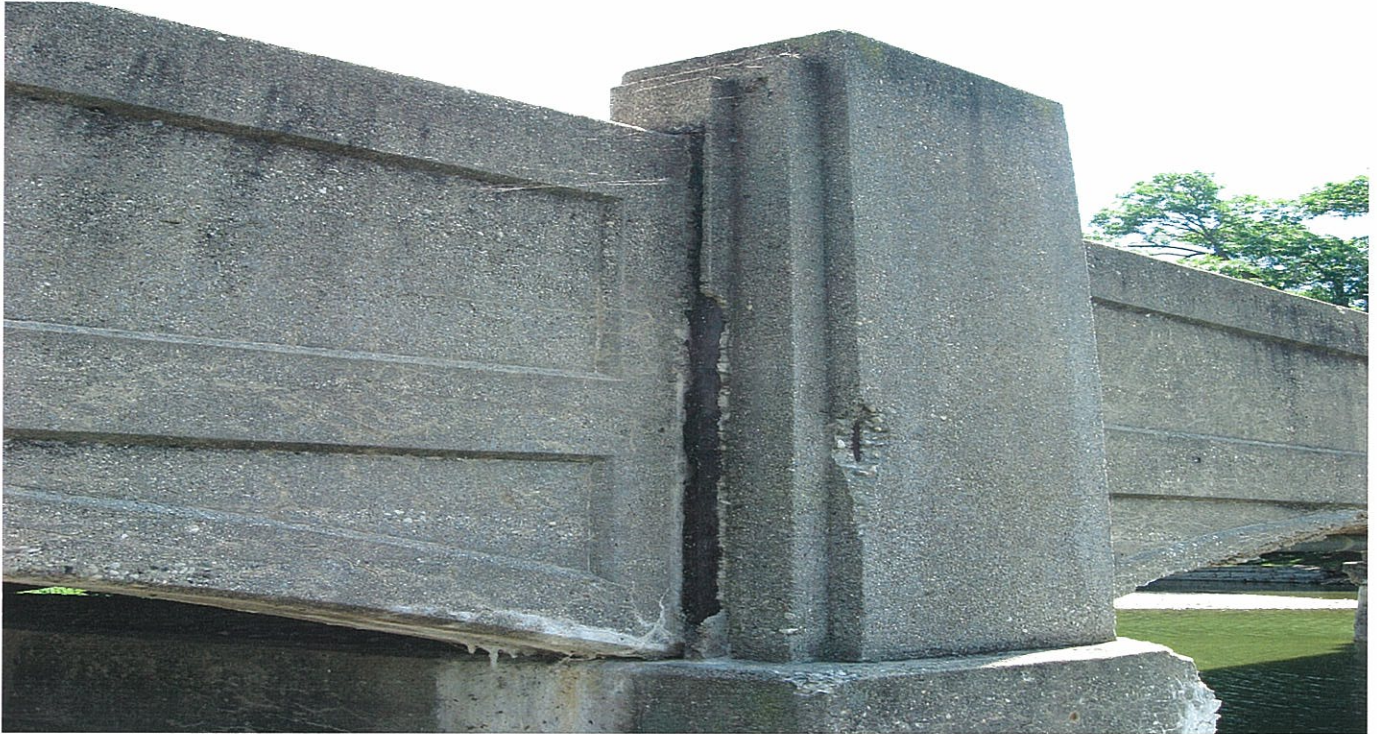
Under Bridge Typical Connection for Beam to Pilaster

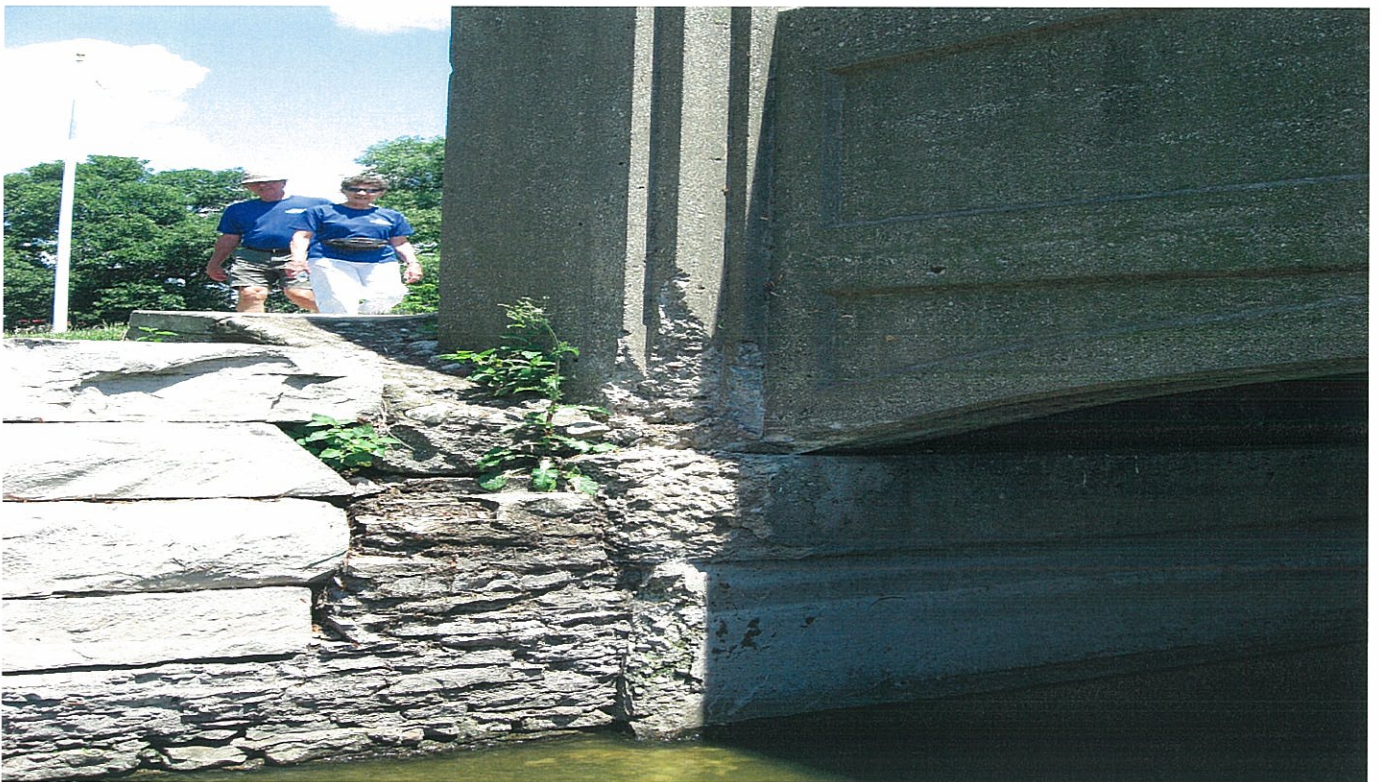
Under Bridge Northwest Side of North Abutment
