# Sewalls Falls Bridge 2012 In-Depth Inspection

Prepared for the  
**CITY of CONCORD, NEW HAMPSHIRE**  
**ENGINEERING SERVICES DIVISION**

March 2012

## **SEWALLS FALLS BRIDGE** **2012 IN-DEPTH INSPECTION**

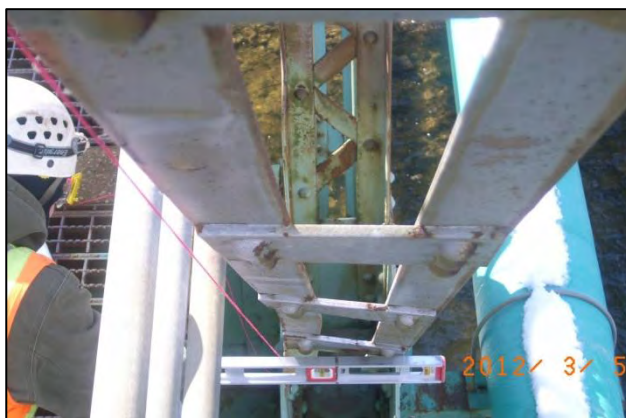
**Figure 5: Documentation of impact damage**

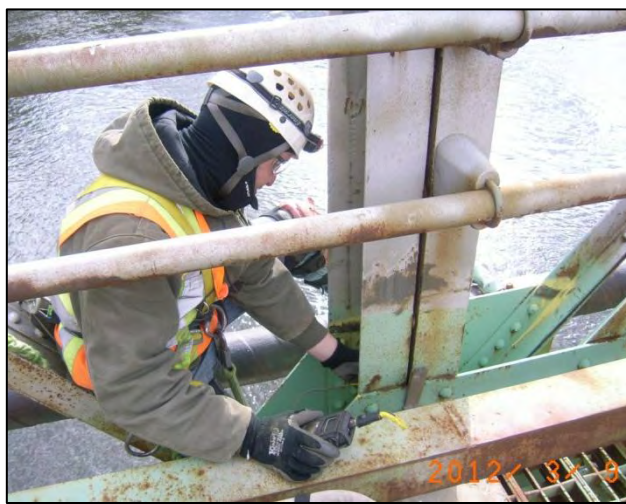
**Figure 6: Measuring section loss on a truss vertical**

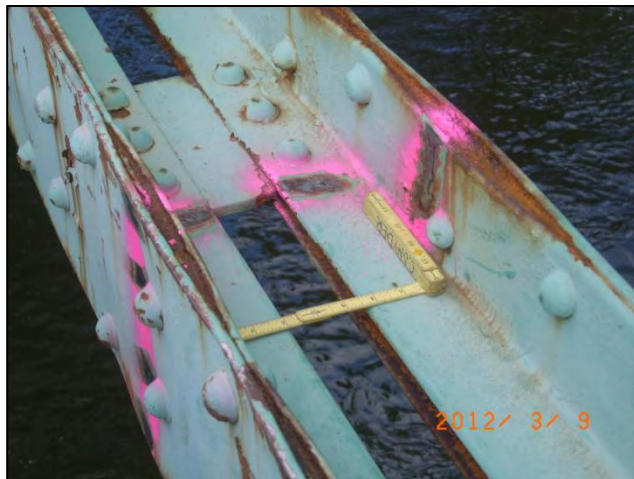
Along the truss bottom chords, there is intermittent crevice corrosion and section loss in each truss panel (Fig. 10). Some panels have their worst losses at the panel point gusset plates, others occur between panel points. The greatest section losses found among all truss bottom chords was 27% on Span 1 Right Truss member L0L1. Similar losses were encountered at Span 1 Left Truss member L6L7 (26% SL); and Span 2 Left Truss member L2L3 (26% SL). See Table 2.

Photo 24: Span 2 Left Truss - L2L3 at 5<sup>th</sup> tie plate:  
Section loss <12-0315>

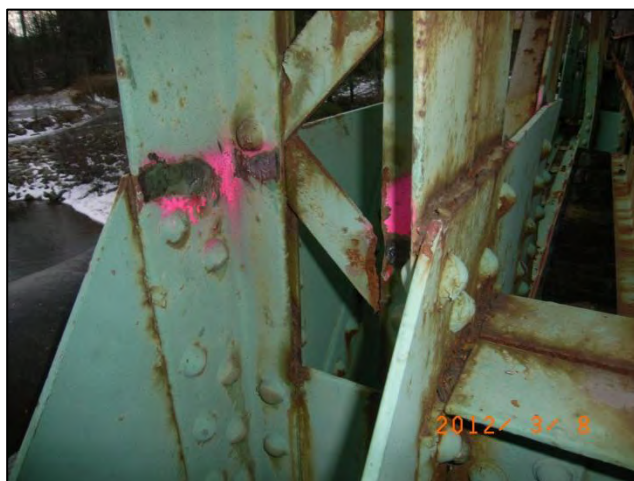
Member	Type	Size <sup>2</sup>	Span 1 Left Truss	Span 1 Right Truss	Span 2 Left Truss	Span 2 Right Truss
L0U1 & U8L9	End Posts	2-C12 x 25 plus plate 18 x $\frac{3}{8}$ "	No significant section loss (NSSL), or impact damage			
U1 through U8	Top Chords	2-C12 x 20.5 or 35 plus plate 18 x $\frac{3}{8}$ "				
L0L1 & L1L2	Bottom Chord	4-L5 x 3 x $\frac{5}{16}$ "	4%	<b>27%</b> Photo 21, 22	3%	3%
L2L3	Bottom Chord	4-L5 x 3½ x $\frac{5}{16}$ " plus 2-Pl. 11 x $\frac{5}{16}$ "	17%	15%	<b>26%</b> Photo 23, 24	16%
L3L4	Bottom Chord	4-L5 x 3½ x $\frac{7}{16}$ " plus 2-Pl. 11 x $\frac{3}{8}$ "	5%	10%	10%	<b>11%</b> Photo 25, 26
L4L5	Bottom Chord	4-L5 x 3½ x $\frac{1}{2}$ " plus 2-Pl. 11 x $\frac{3}{8}$ "	NSSL	NSSL	≤5%	<b>5%</b> Photo 27, 28
L5L6	Bottom Chord	4-L5 x 3½ x $\frac{7}{16}$ " plus 2-Pl. 11 x $\frac{3}{8}$ "	<b>18%</b> Photo 29, 30	9%	8%	10%
L6L7	Bottom Chord	4-L5 x 3½ x $\frac{5}{16}$ " plus 2-Pl. 11 x $\frac{5}{16}$ "	<b>26%</b> Photo 31, 32	24%	10%	18%

Photo 34: Span 1 Right Truss - U3L3 at L3: Section loss <12-0229>

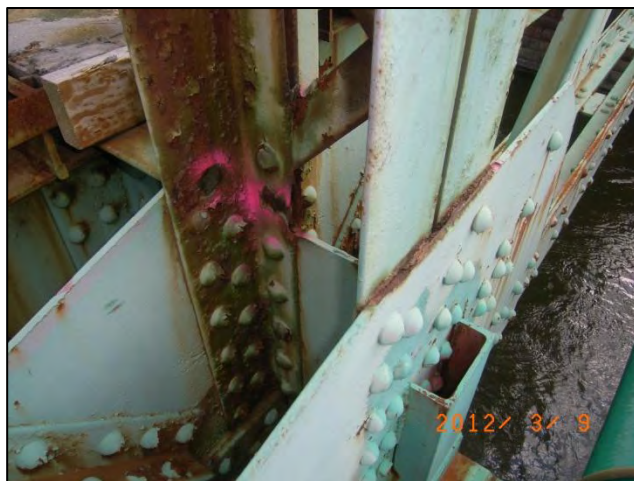
Photo 36: Span 2 Left Truss - U4L4 at L4: Section loss <12-0334>
